**General assessment of the condition of the primary dune parallel to Road PR-187
and Parcelas Suárez both located on the municipality of Loiza, Puerto Rico**

June 6, 2018

Robert J. Mayer Ph.D.
Vida Marina: Center for Conservation and Ecological Restoration
University of Puerto Rico at Aguadilla

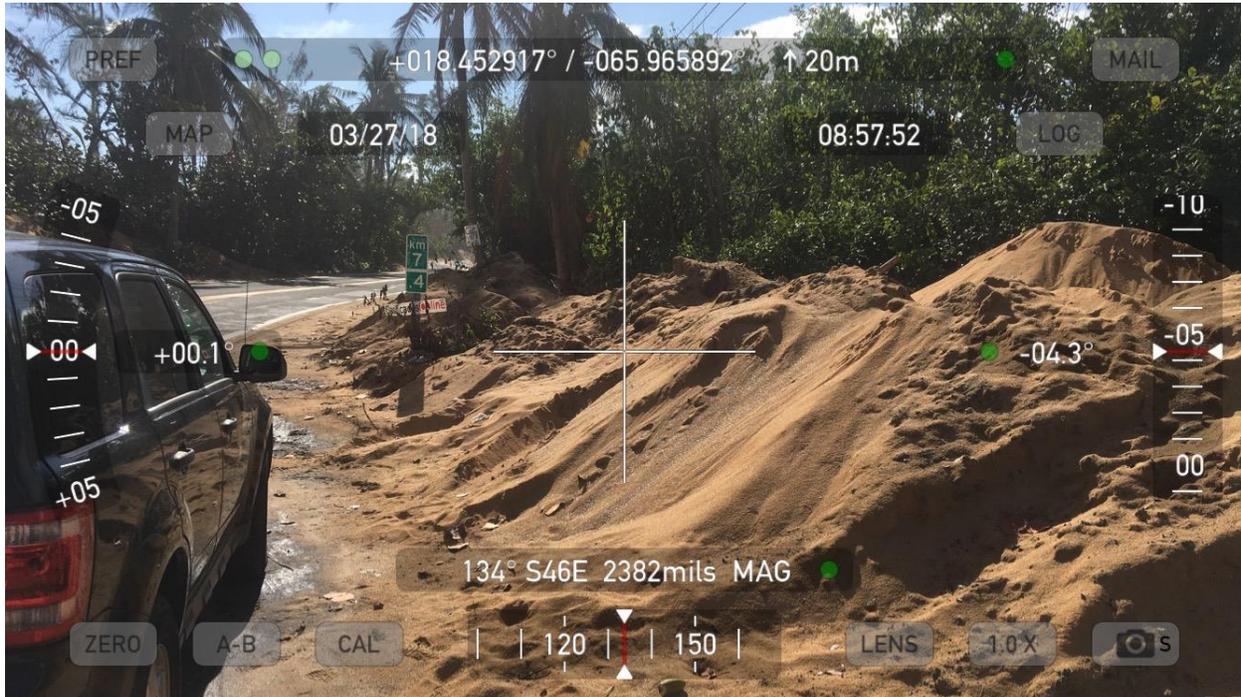
We found high volumes of **displaced sand** on both sides of road PR-187 especially on breached portions of the dune.

Figure 4. Displaced sand on the landward side of PR-187. This is very common along this route especially in areas where the dunes were breached.

A formal **sand relocation plan** for displaced sand needs to be designed and strictly implemented in this area. See figure 8 for an example of a sand relocation application form used on the mainland United States. The sand should be immediately relocated to the berm area of the beach.

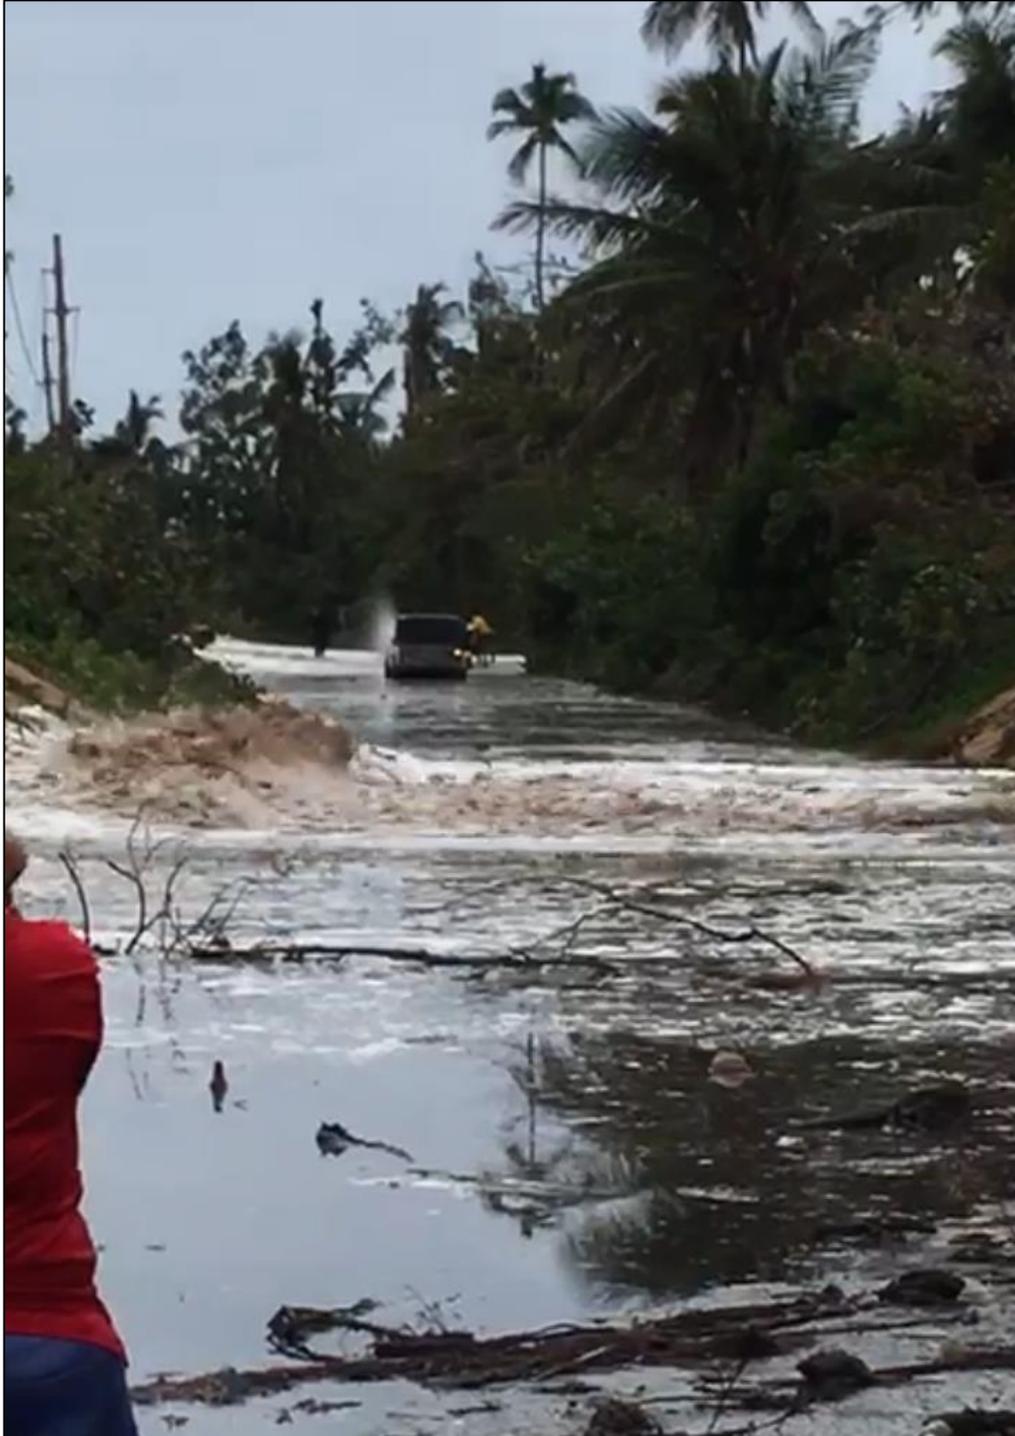
We also identified many non-vegetated and highly eroded **breaches**, used as random beach accesses, on this line of primary dune. Areas of the dune that have significant vegetation cover withstood the effects of the strong wave action of the storms while the breached areas served as inlets of large volumes of sea water that caused massive flooding on this area (figure 5).

Figure 5. Stream of seawater flowing from the beach to PR-187 through a breached beach access on the primary dune during the week that winter storm Riley affected the Puerto Rico coast.

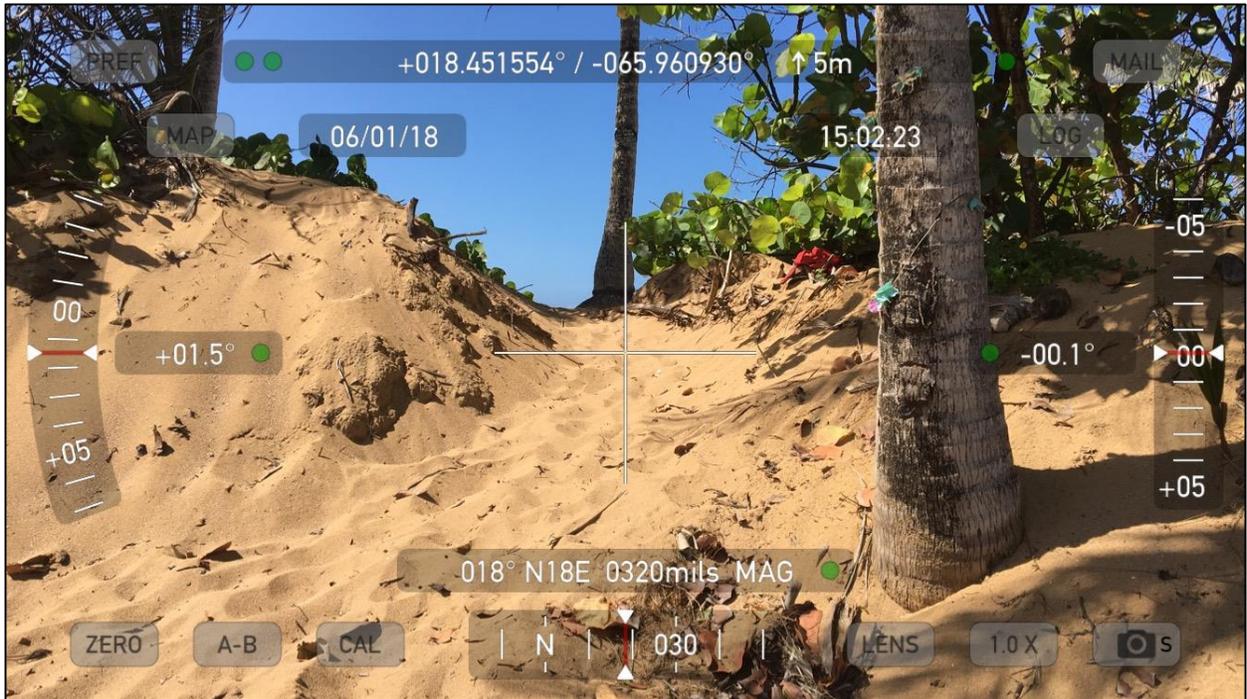
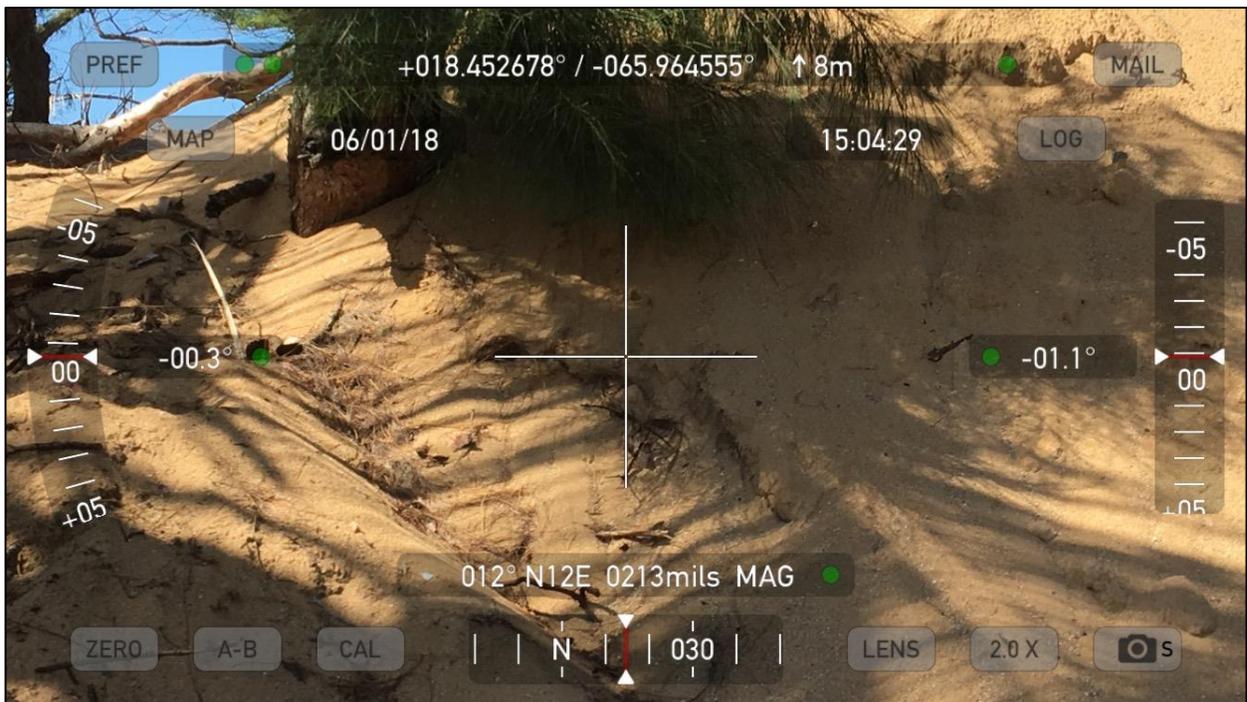
Many areas on these **random beach accesses** have no vegetation, a factor that reduces the stability of the dune (figure 6). We also found several **wooden boardwalks** that are in very bad (even dangerous) condition and should be repaired immediately. Additional better-designed and longer boardwalks should be installed along this area of dunes in order to re-direct foot traffic (which is heavy in some areas) away from vegetated areas. This simple measure would reduce flooding of this road significantly. If foot and sometimes vehicular traffic is not redirected the problem of flooding and massive sand displacement will not be resolved.

Figure 6. Two of the many random beach accesses along the primary dune parallel to PR-187.

We also suggest the installation of **wooden sand-trapping structures** (wooden pallets or biomimicry matrices) on each of these sites to rapidly increase the height of the problem areas of these dunes especially in breached areas. The structures should be located on the crest of the existing dunes. This will be coupled to planting of **fast-growing pioneer vegetation** that will stabilize the accumulated sand.

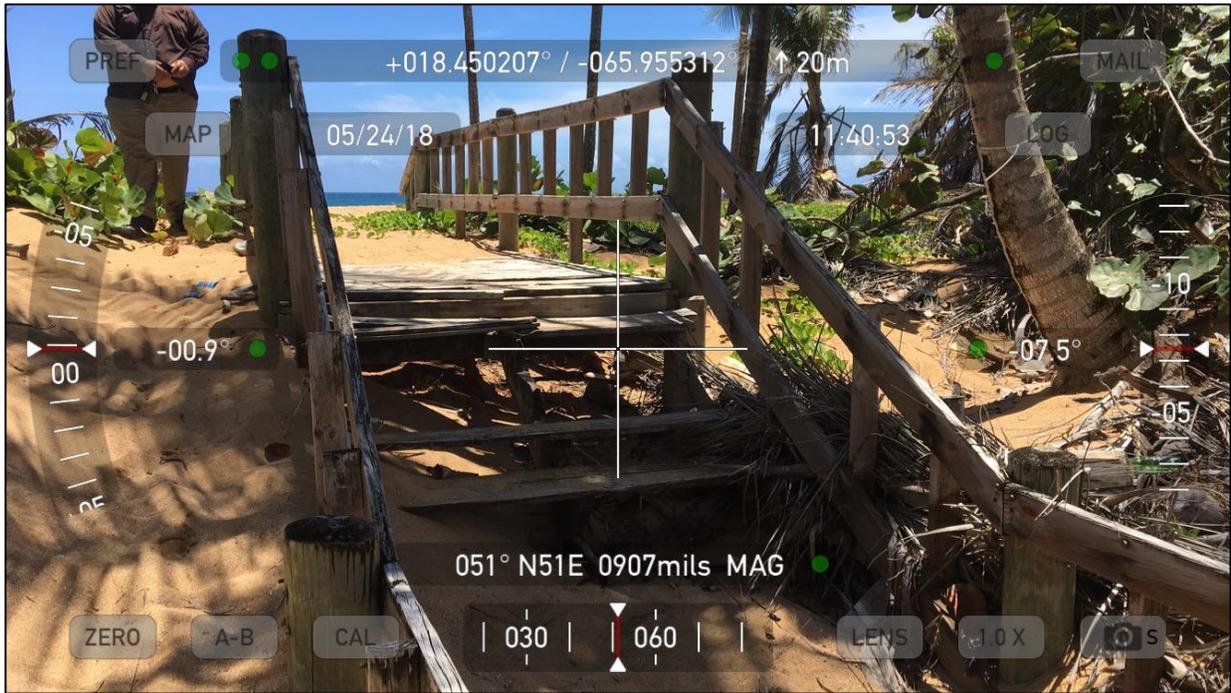
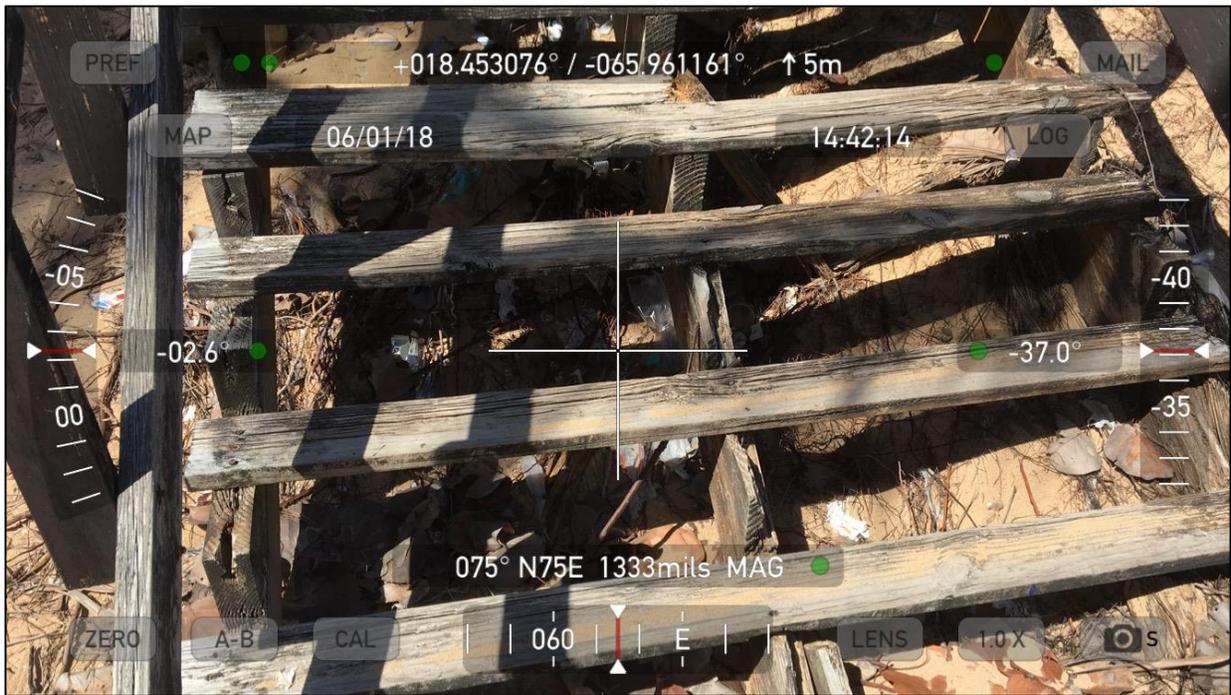
Figure 7. One of the wooden boardwalks on the primary dune along PR-187.

We have a method for the analysis of foot traffic patterns on highly visited areas allowing us to locate the new **wooden boardwalks** in the best possible locations. This integrates the use of a UAS and photogrammetry software (Pix4D and Sample Point). Our boardwalks have been very effective in redirecting foot traffic in the Isabela area and even withstood the recent storms. Our data from previous projects on the western coast of the island suggests that this is the only effective way to increase vegetation cover in areas of high foot traffic such as this one. We are recommending the installation of wooden boardwalks that will reduce the incidence of random foot traffic and plant trampling that promotes erosion of the primary dune. The **random accesses** should be closed with exclusion fencing and signs should be installed in these areas in order to make people aware of the problem that these breaches on the primary dune cause and the direction to the nearest designated beach access (walkover).

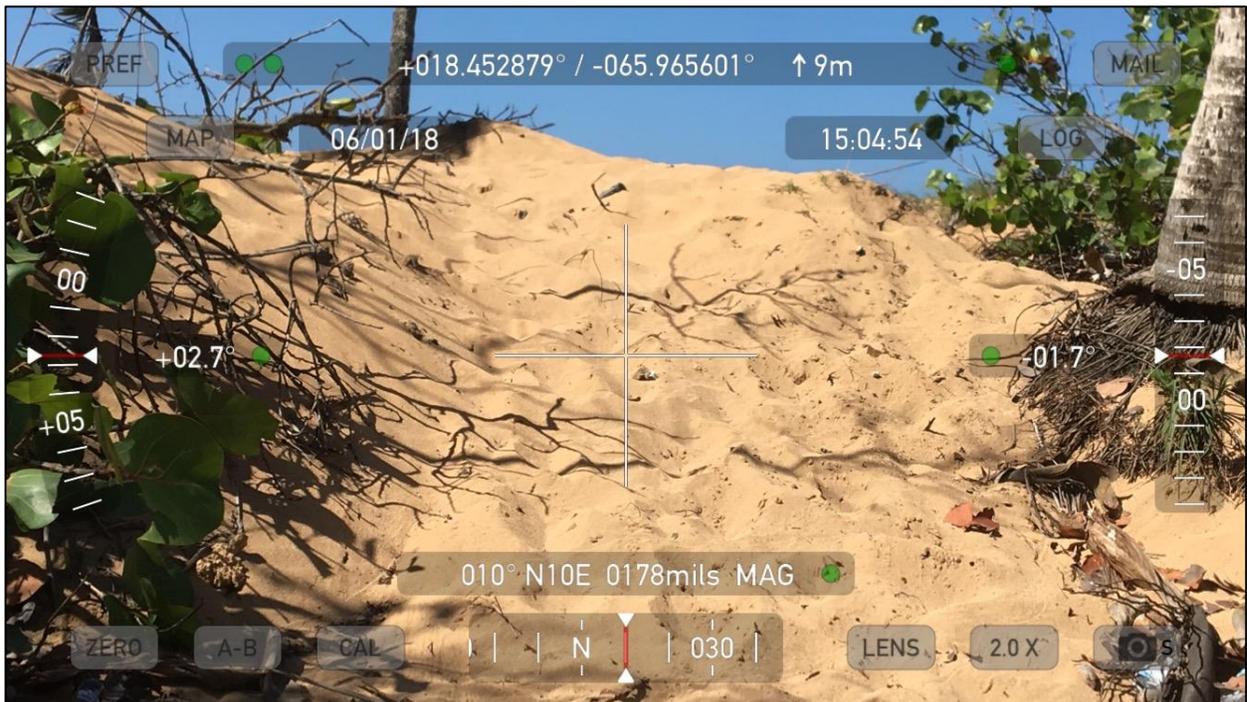
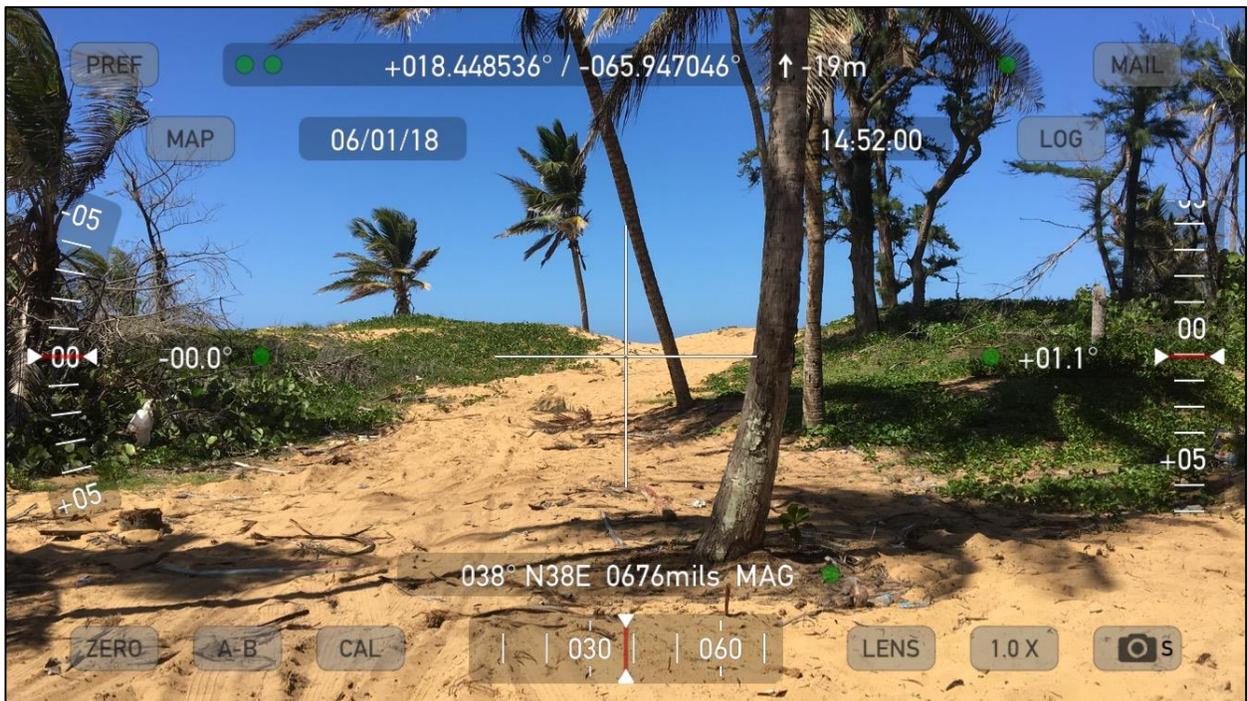
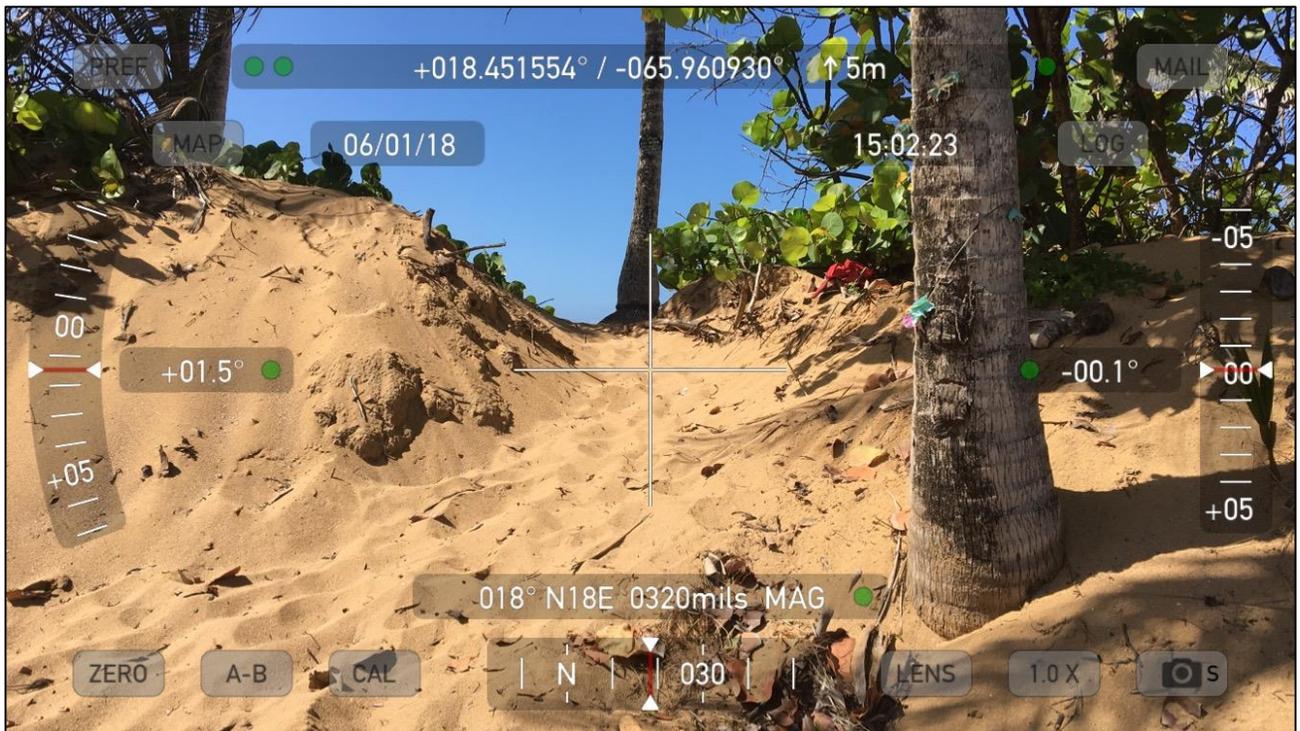
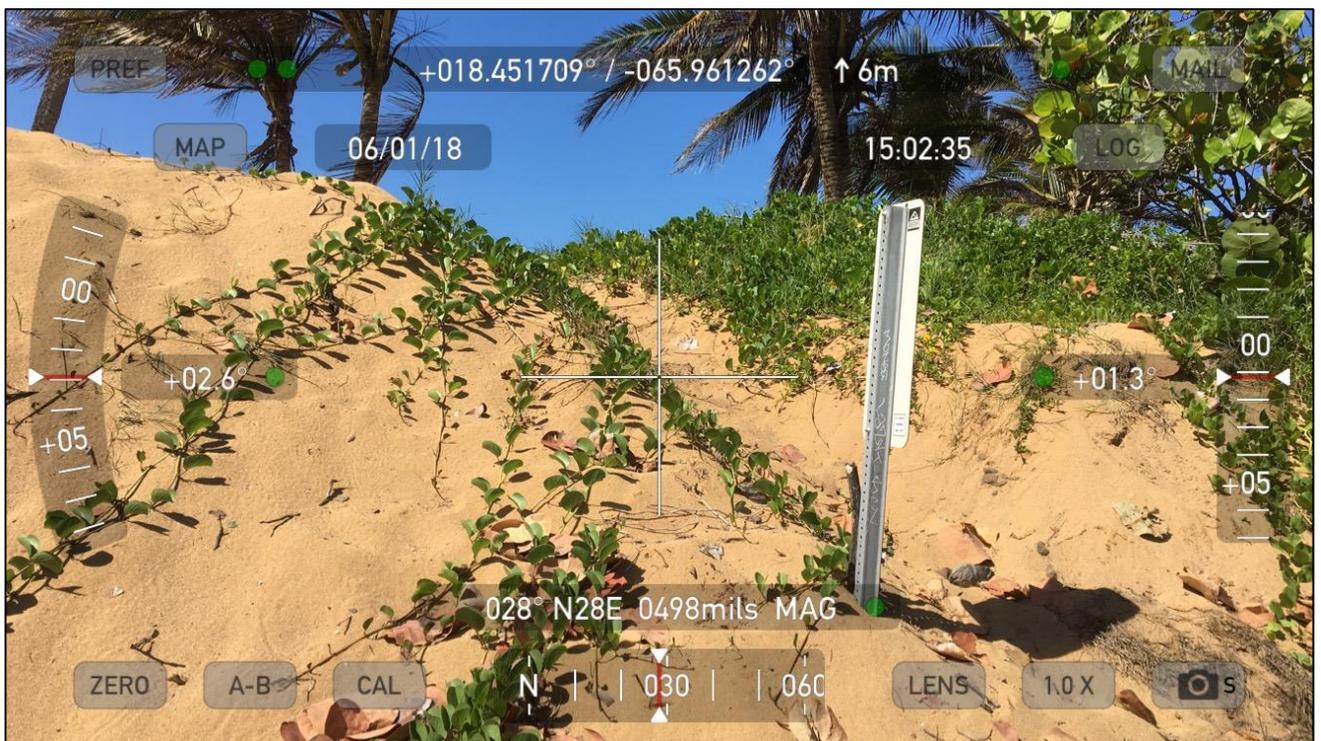
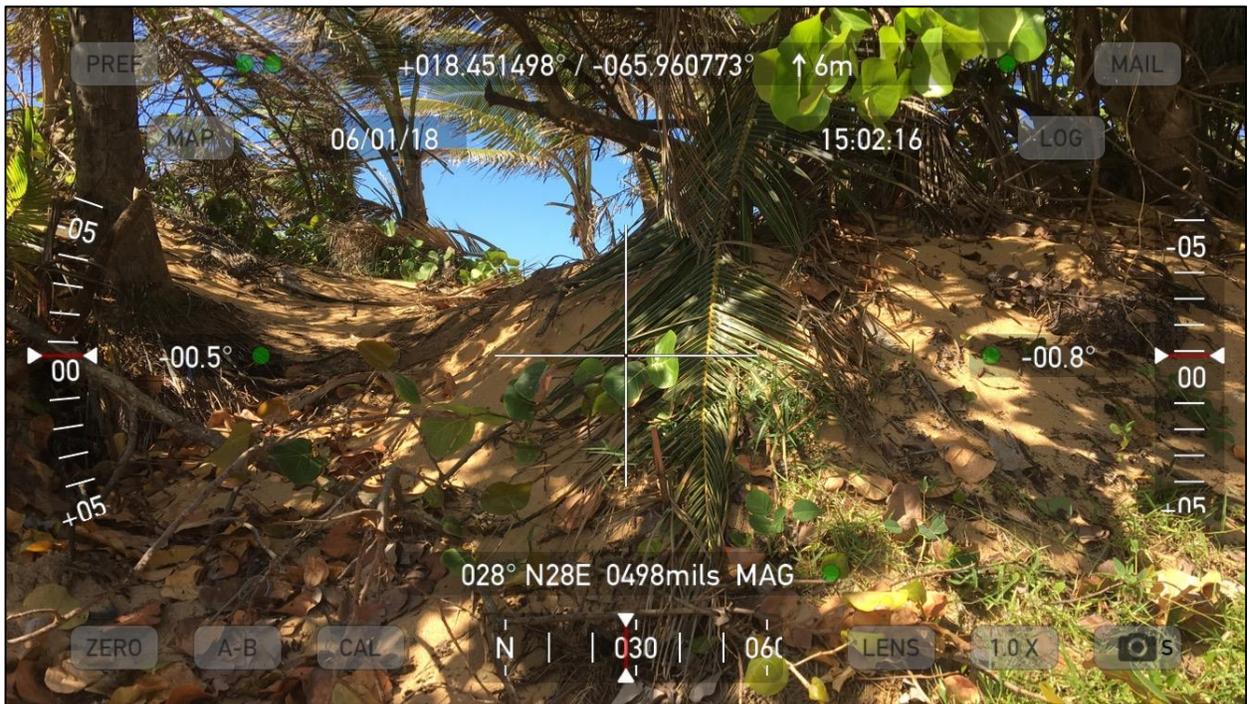
Additional breaches that should also be repaired.

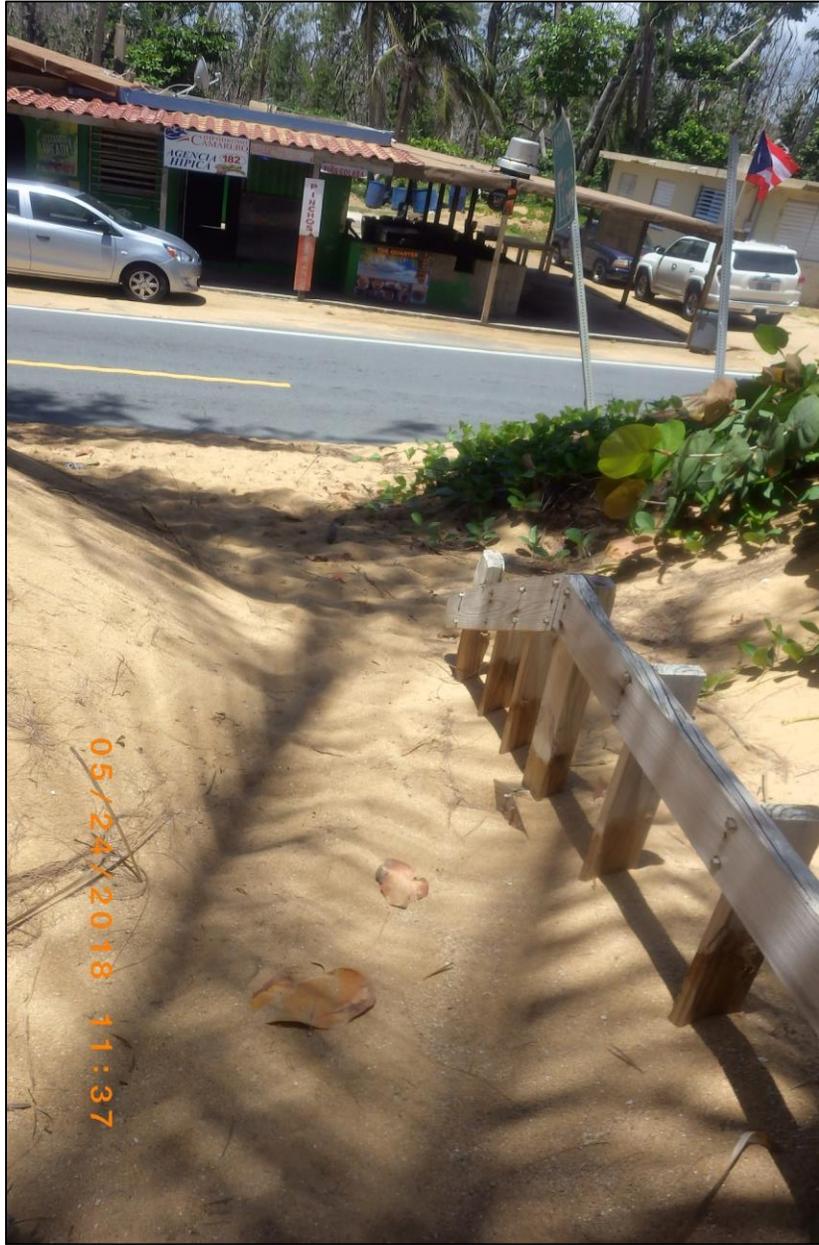
The same boardwalk viewed from another angle.

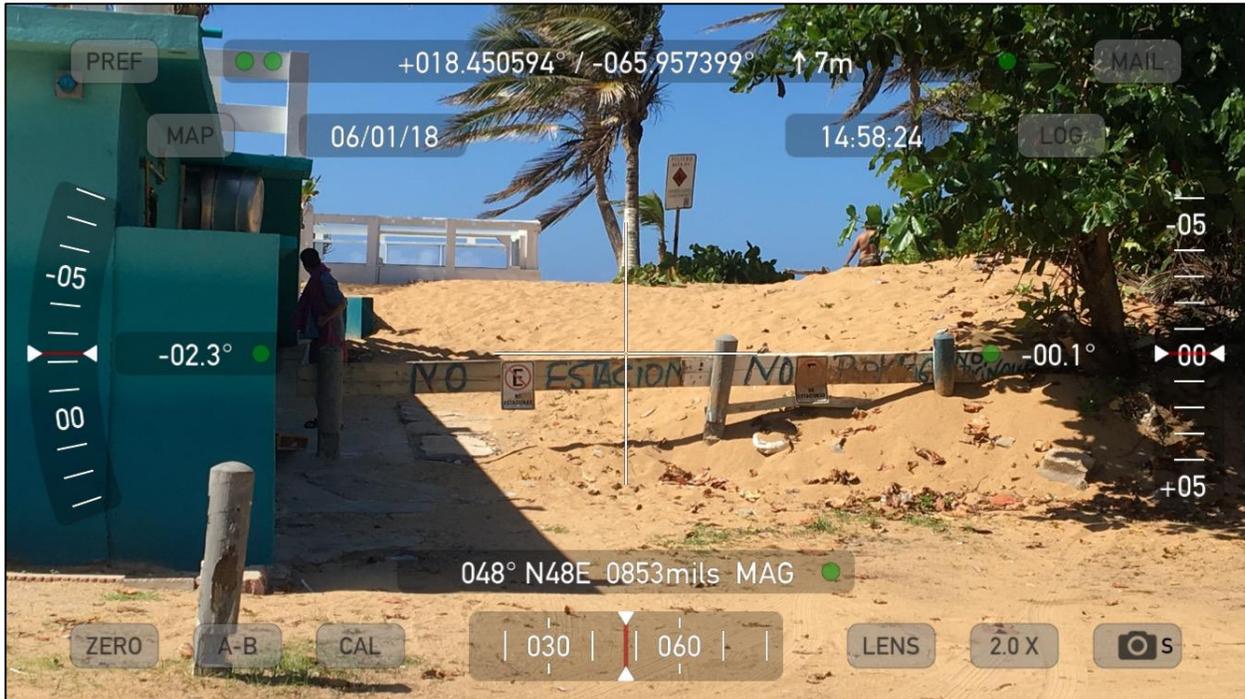
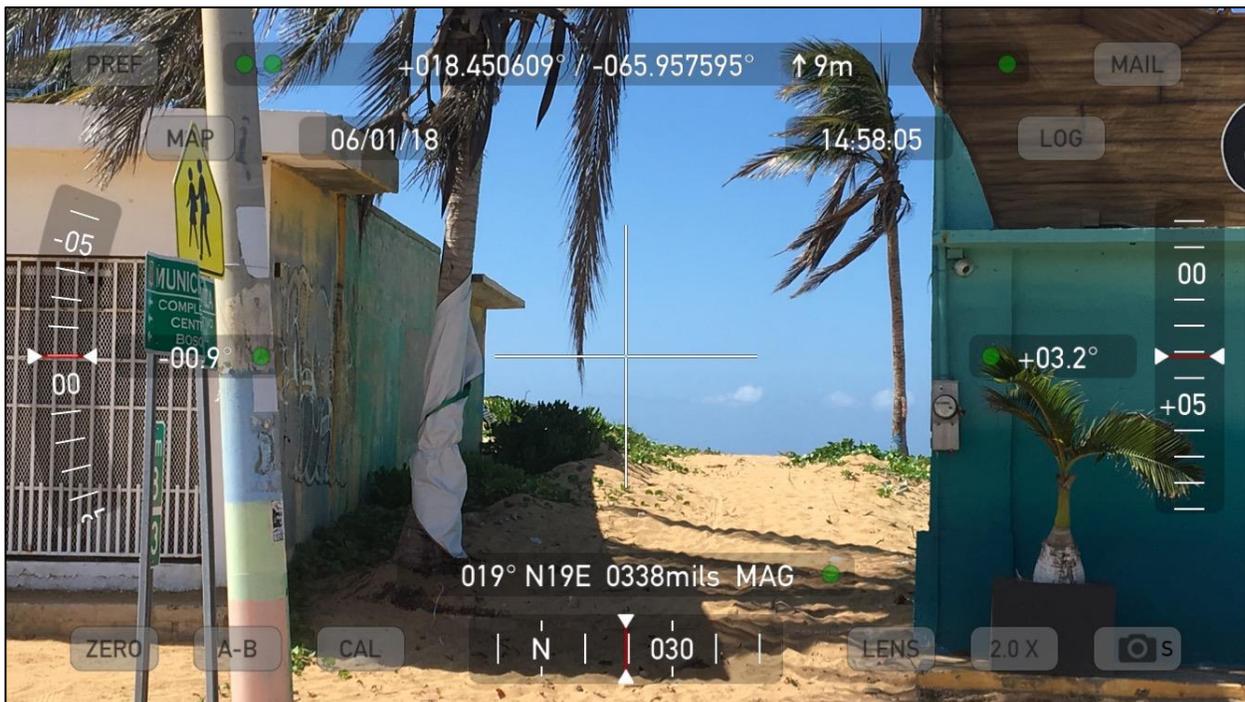
Site 5.

There are three accesses between the buildings. We suggest the access on the top picture be closed with exclusion fencing and that a wooden boardwalk be installed between the buildings on the lower picture.

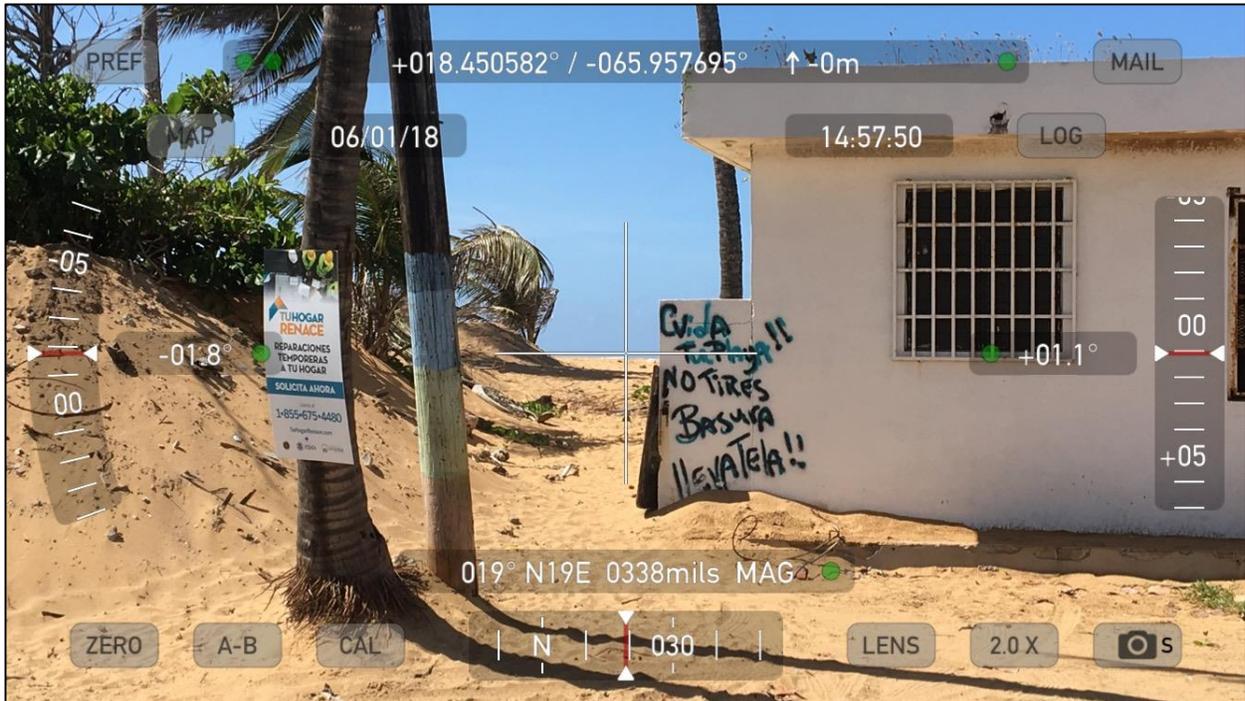
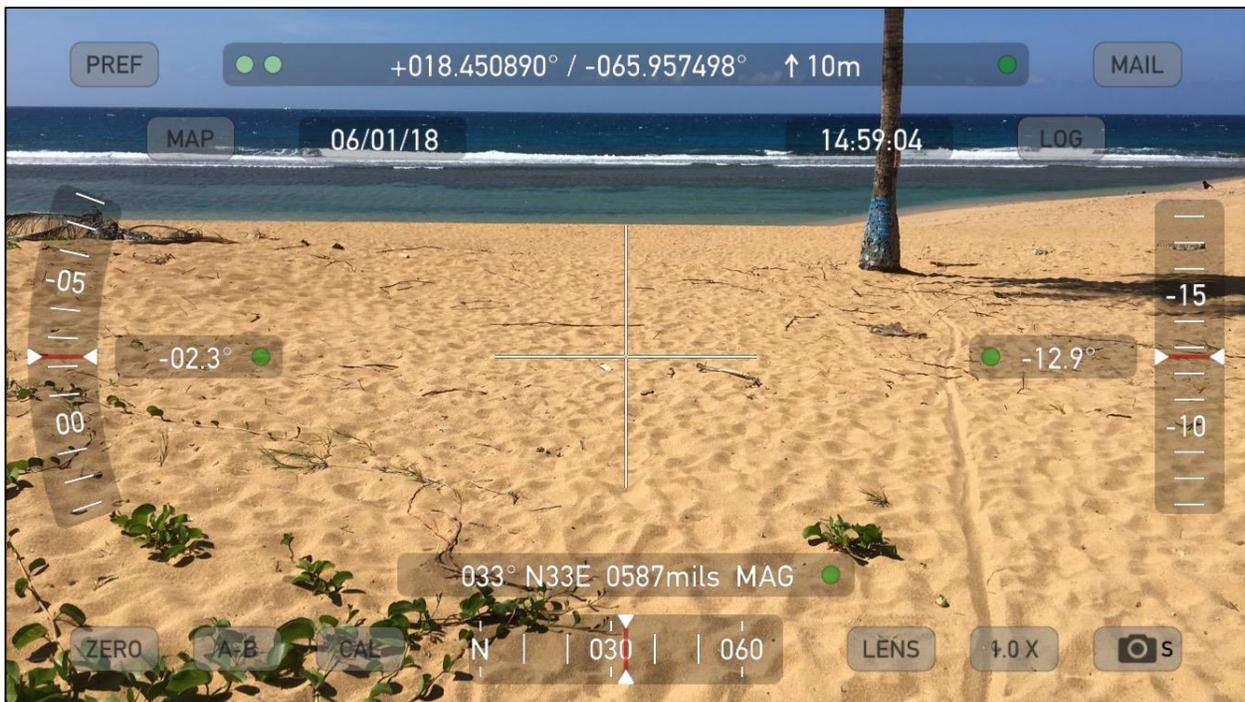
The access on the left of the building on the top picture should also be blocked. The beach area behind the buildings (bottom picture) should be restored with sand trapping devices and pioneer vegetation such as the beach bean thriving on the same picture. The growth of this plant in this area is limited by the heavy foot traffic (note footprints) and dragging of coolers.

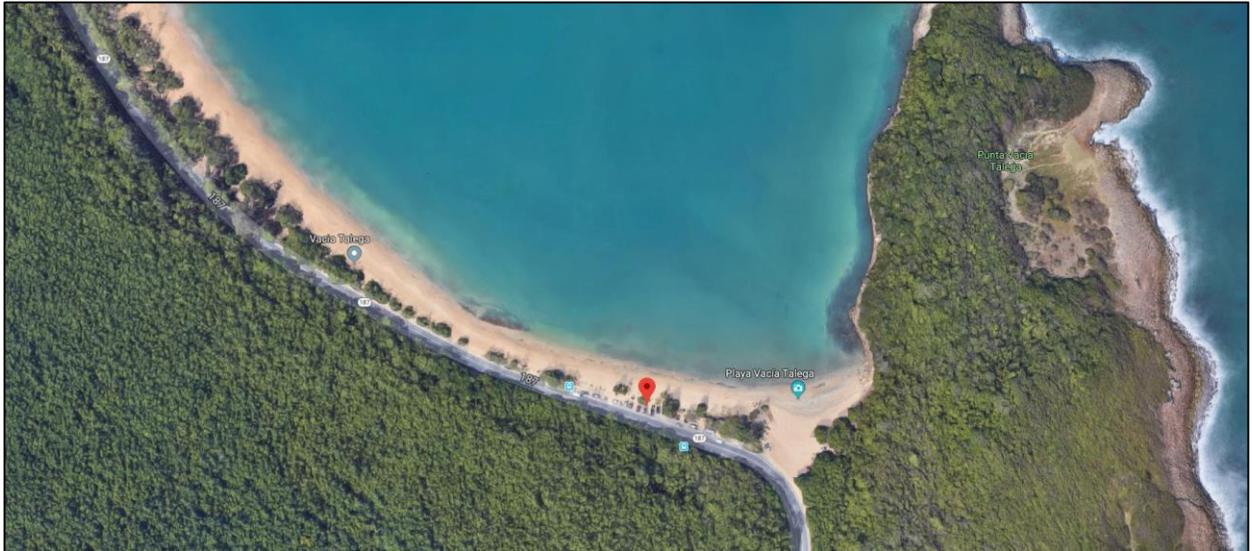
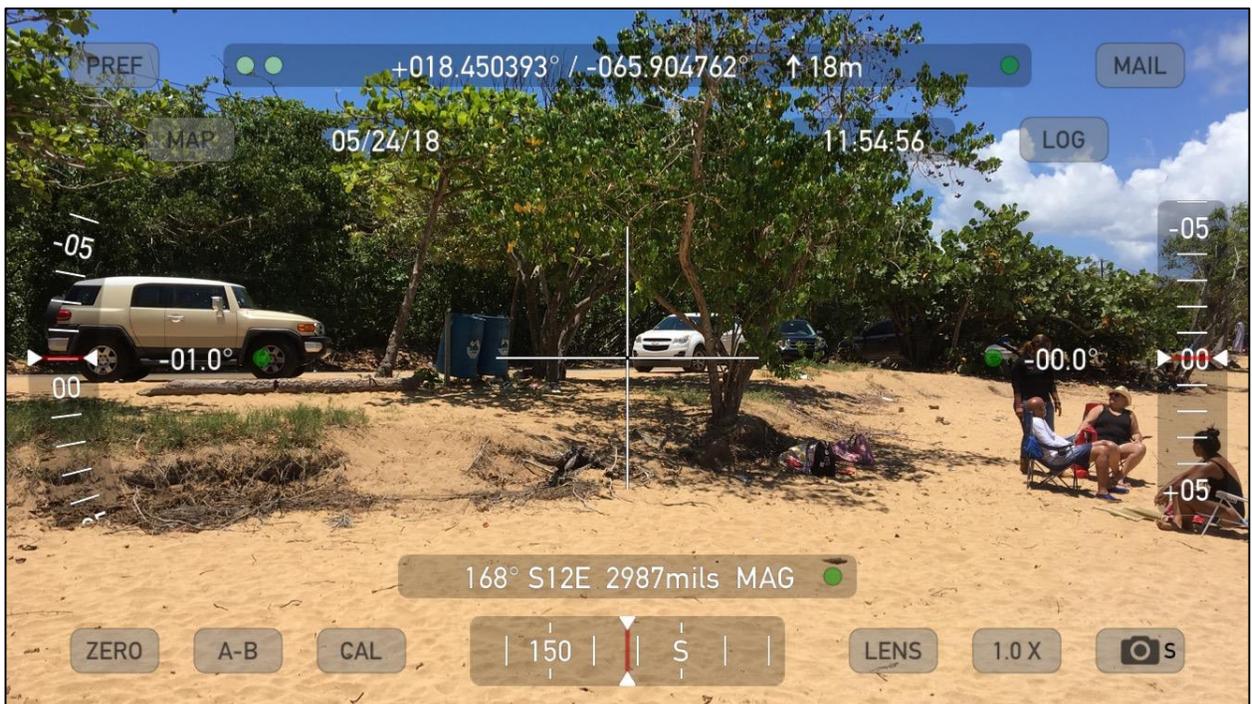
Site 6 (Vacía Talega).

This is Vacía Talega Beach is an area of heavy recreational use. This area experiences heavy foot and vehicular traffic specially during weekends and holidays. We recommend exclusion fencing in the area to reduce vehicular damage to an incipient dune and pioneer vegetation. Information signs and at least two wooden boardwalks could significantly contribute to at least some sand accumulation (the morphology of the coast does not

promote sand transport – personal communication with Dr. Rosana Grafals and Dr. Maritza Barreto from UPR) but excluding traffic from the beach could promote the growth of stabilizing plants and some sand accumulation that would make this area more resilient to extreme weather events.

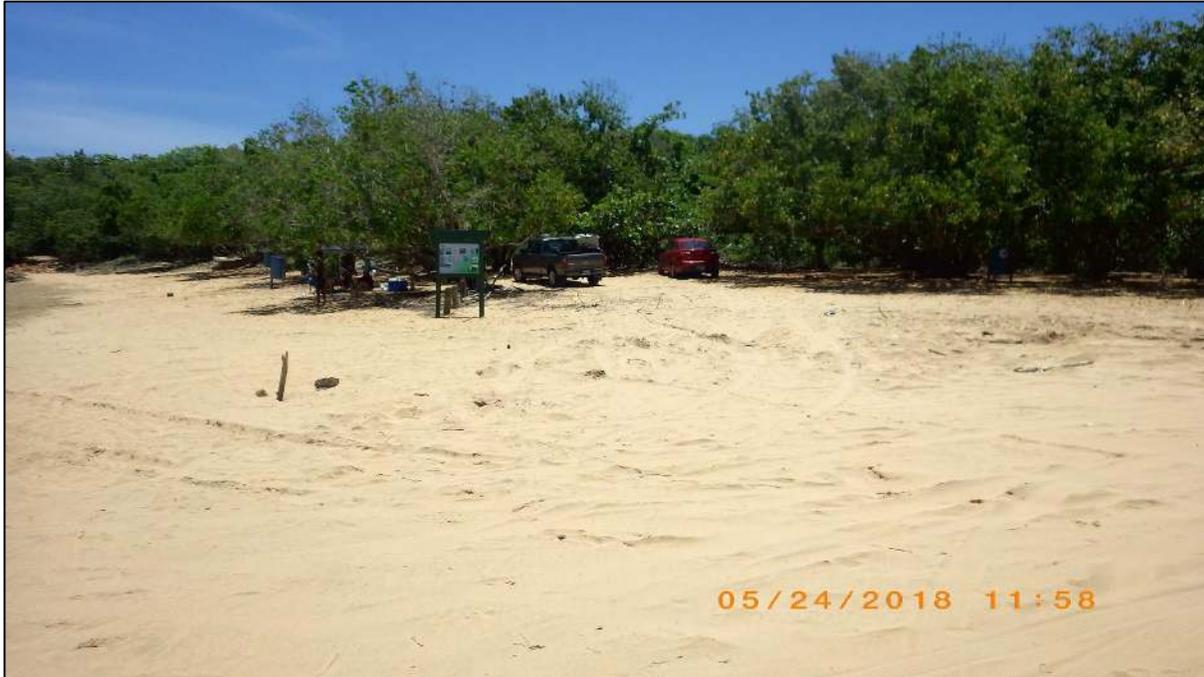
This unprotected beach leaves road PR-187 exposed to heavy wave action and flooding during strong storms. This area experienced heavy flooding during winter storm Riley (see below).

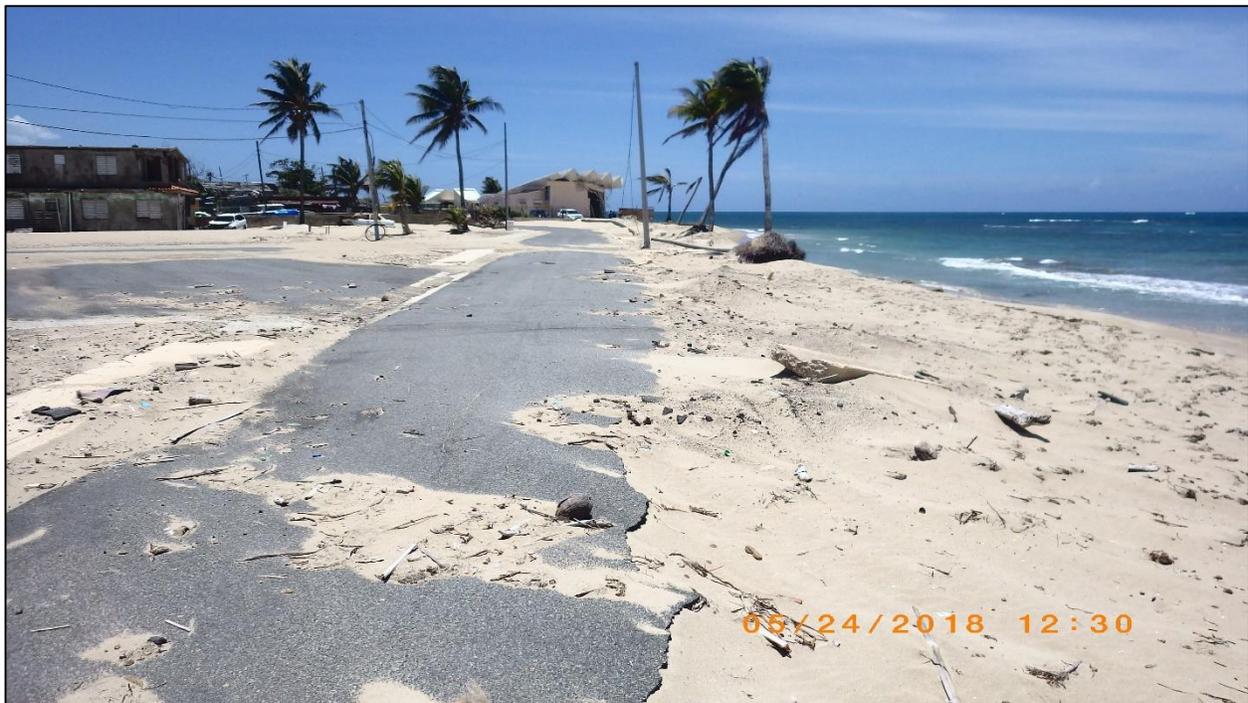
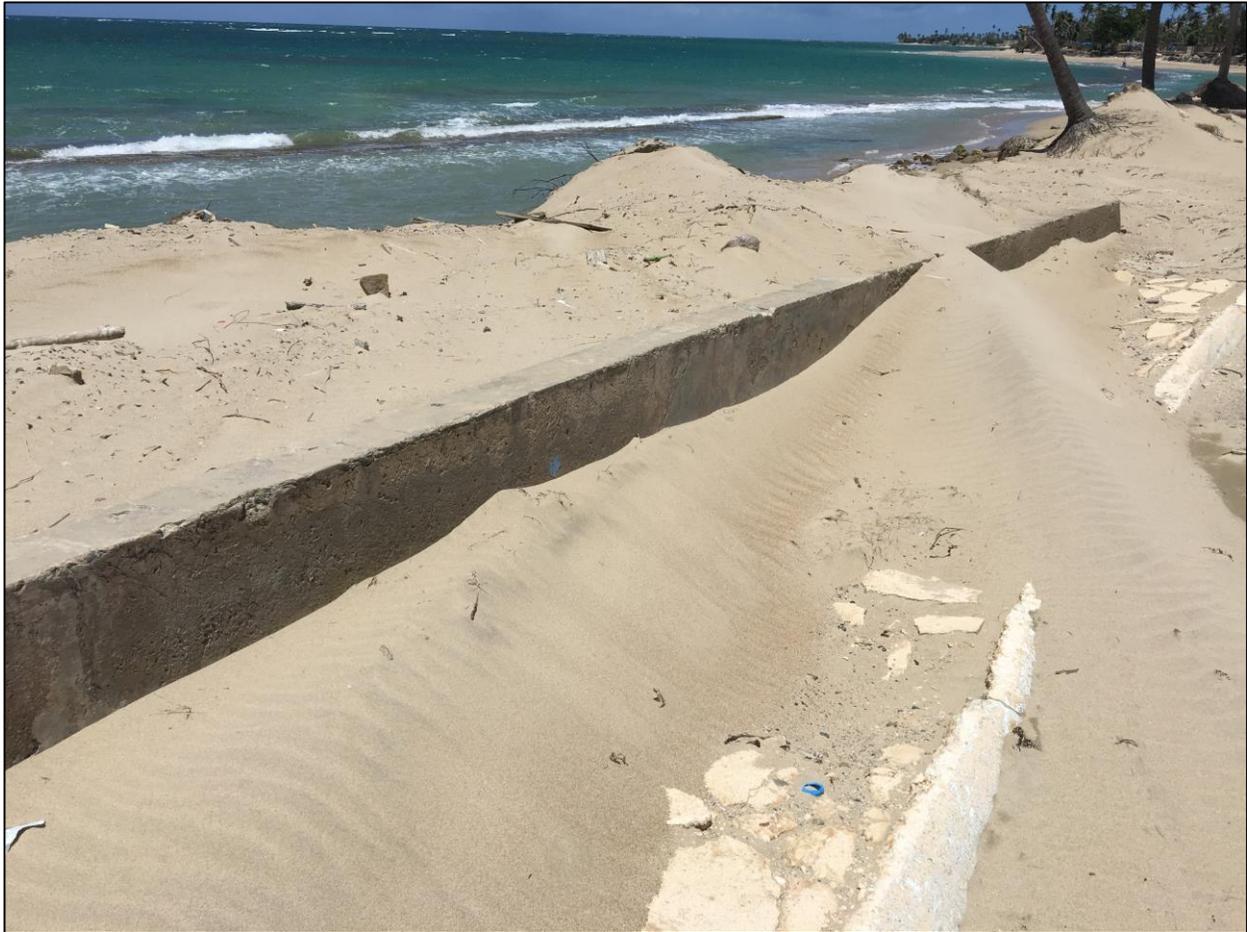
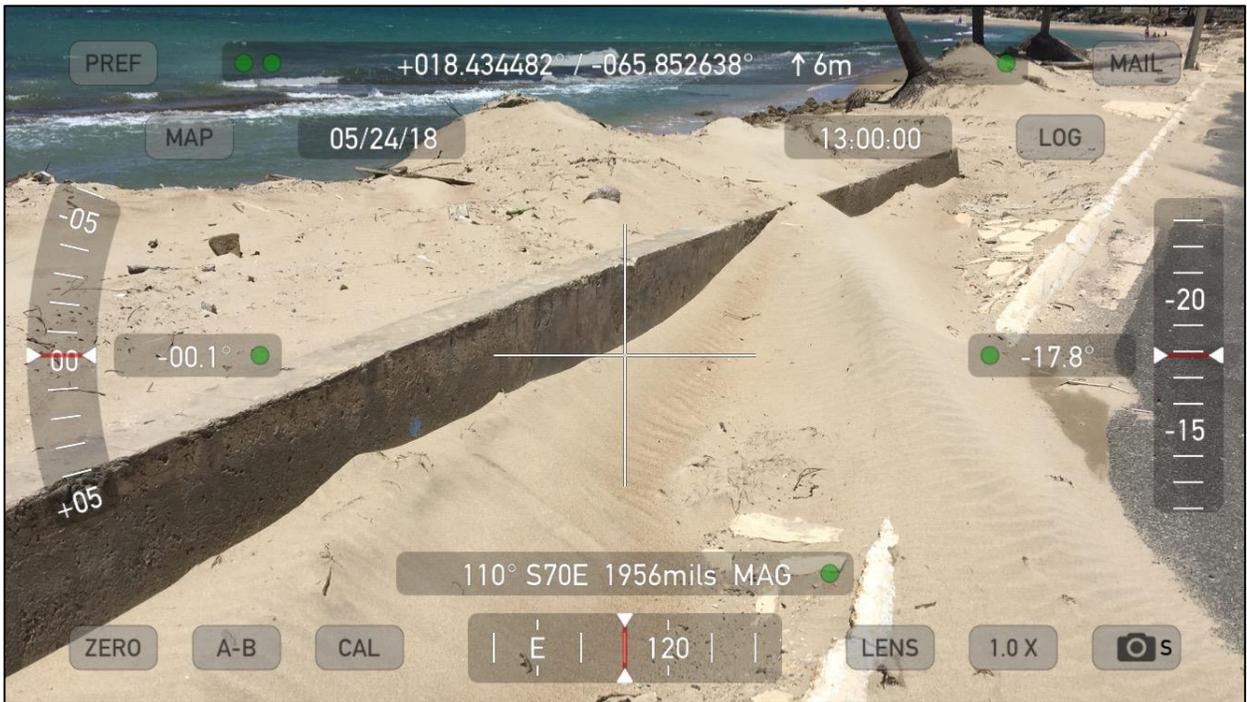
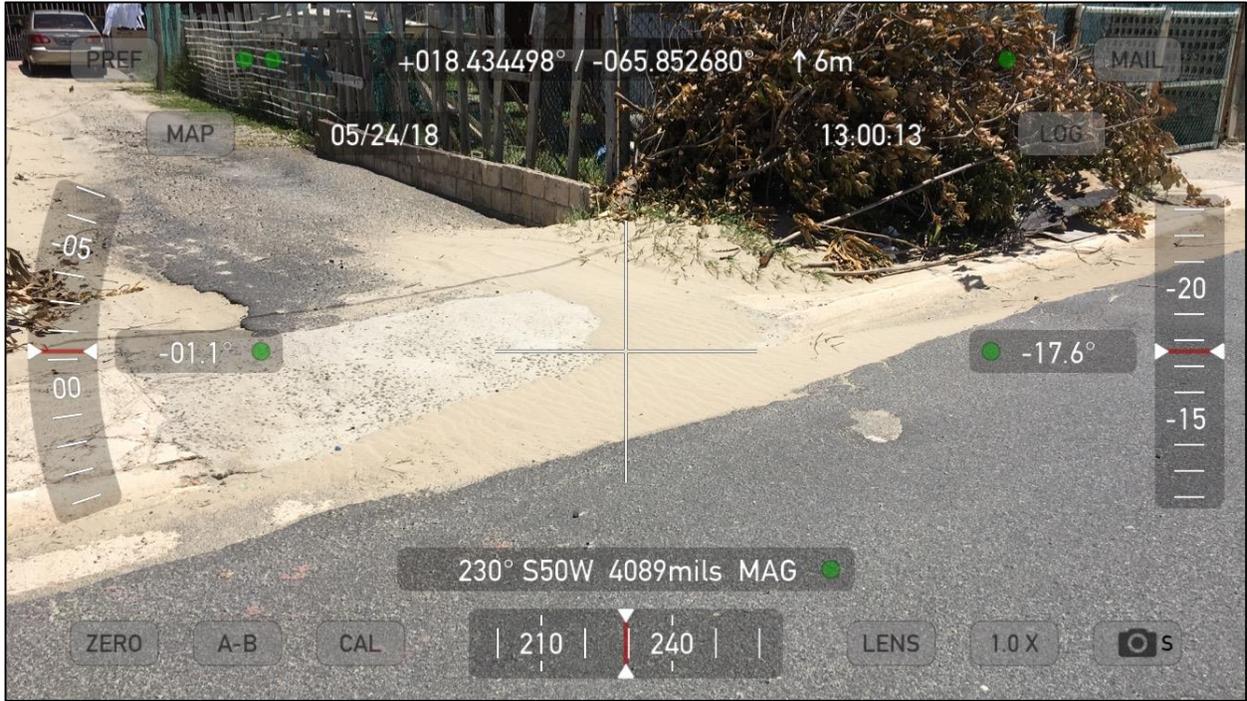
Road Punta del Atlántico in Parcelas Suárez was severely affected by wave action during the extreme events of 2017 and early 2018. The road was closed and there are plans to install hard structures to protect the coast. Our recommendation is to immediately demolish the extremely dangerous Centro Comunal Parcelas Suárez building and install experimental sand trapping devices in the area as well as exclusion vegetation followed by the planting of pioneer vegetation. Even though Dr. Maritza Barreto thinks there is no significant landward sand transport we were able to witness a significant amount of sand (brought in from nearby areas of the coast by winter storm Riley?) being constantly blown on-shore. We also saw ripples on the sand suggesting sand accumulation and significant amounts of sand being accumulated on the yards of nearby houses. The pavement of the closed road should be removed and the area should be planted with pioneer dune vegetation combined with biomimicry matrices as a last alternative before installing hard structures on this area. We perceived more support to green infrastructure by the municipal government and community members. This is something to be seriously considered. We can monitor sand accumulation closely using our UAV system and photogrammetry software.

Sand being transported landward and being accumulated on the road and houses in Parcelas Suárez.
