**General assessment of the condition of the primary dune parallel to Road PR-187
and Parcelas Suárez both located on the municipality of Loiza, Puerto Rico**

June 6, 2018

Robert J. Mayer Ph.D.
Vida Marina: Center for Conservation and Ecological Restoration
University of Puerto Rico at Aguadilla

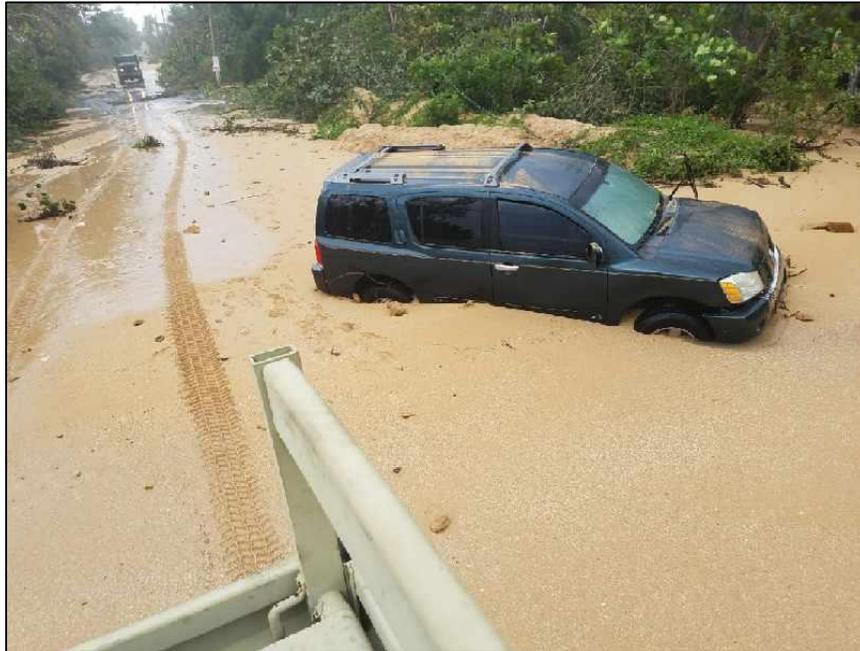
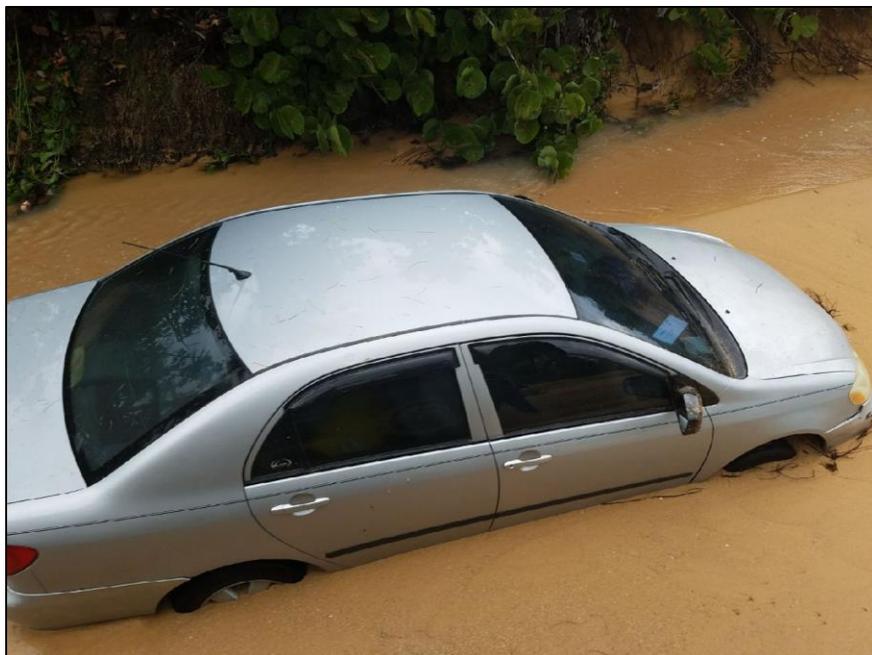
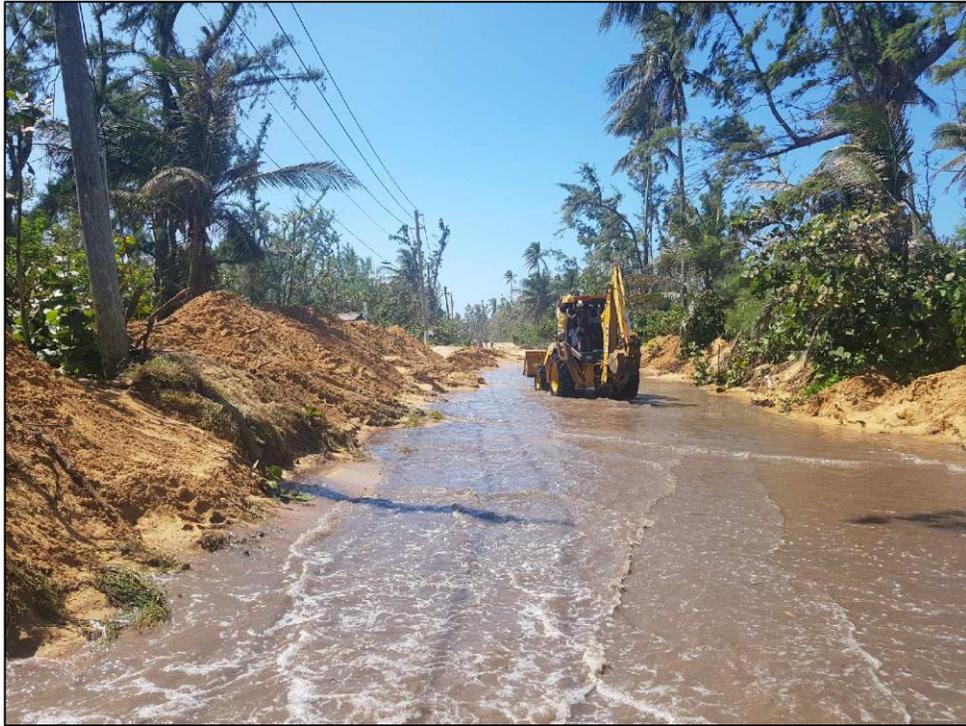
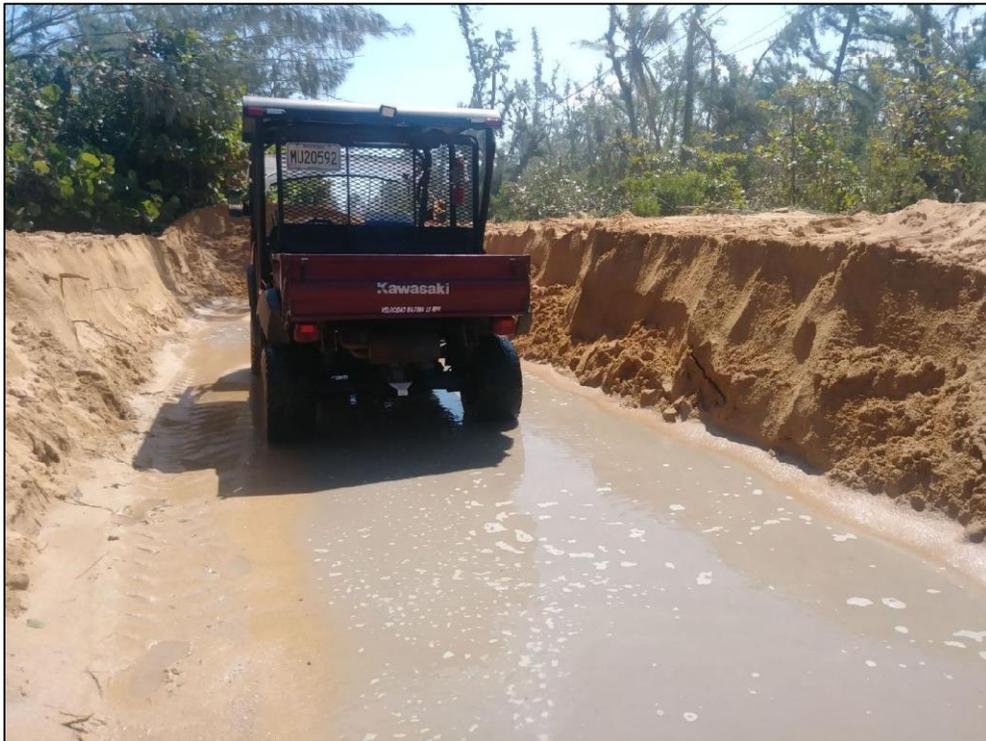
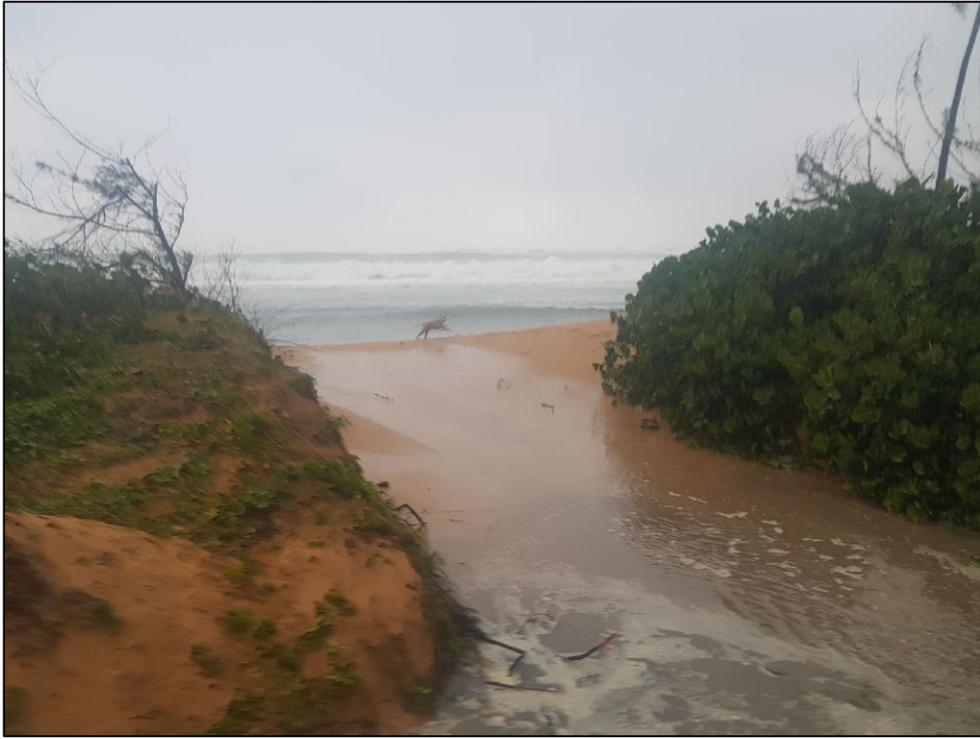
Additional pictures of the flooding along PR-187
