**General assessment of the condition of the primary dune parallel to Road PR-187
and Parcelas Suárez both located on the municipality of Loiza, Puerto Rico**

June 6, 2018

Robert J. Mayer Ph.D.
Vida Marina: Center for Conservation and Ecological Restoration
University of Puerto Rico at Aguadilla

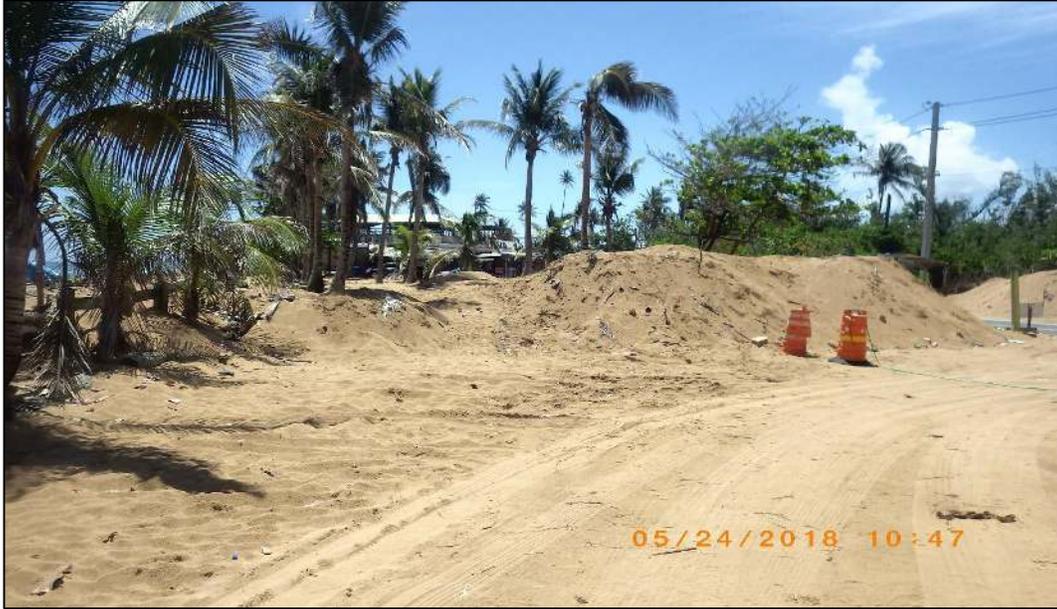
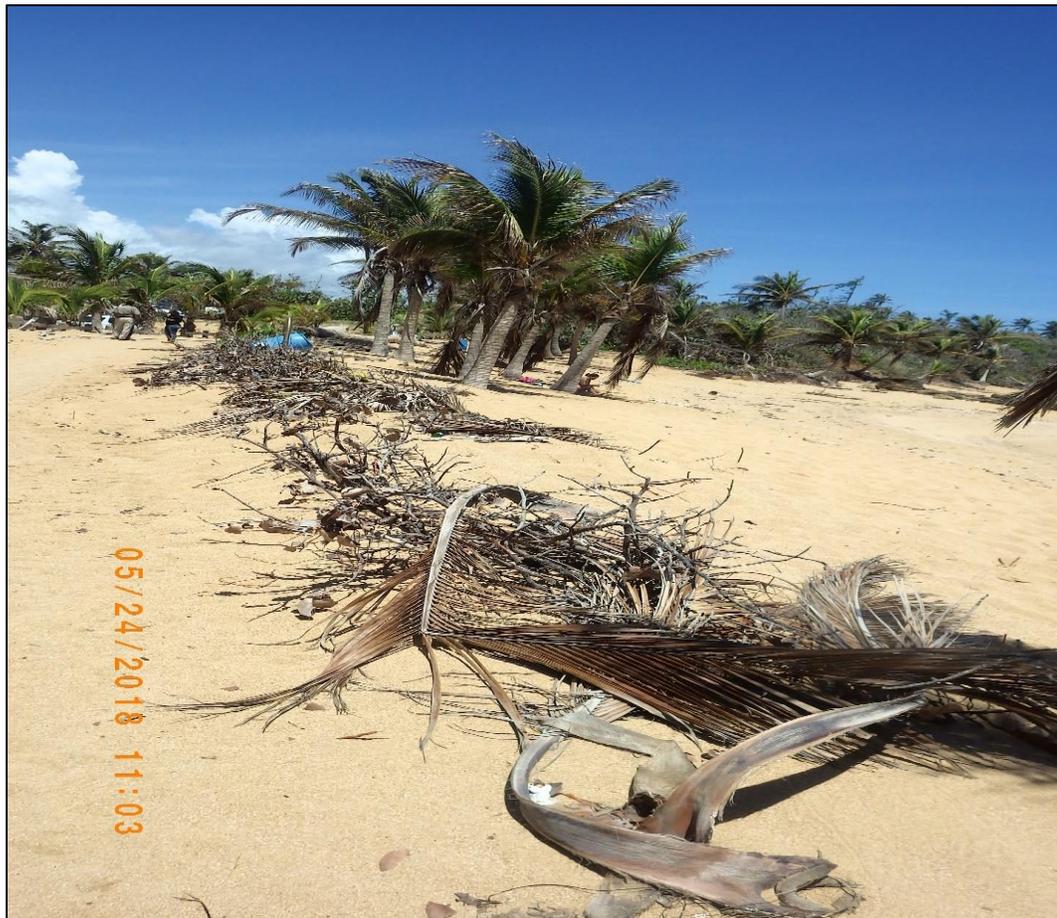
Aerial map of the location. This area is located in front of a food business and a recreational path that we recommend be relocated closer to PR-187 to leave space available for sand accumulation on its original location. We also recommend the installation of a wooden boardwalk, information signs, planting of pioneer vegetation and sand trapping devices. We could detect significant sand transport in this area during our visit. The idea is to help the dune recover to the east of the segment of dune that is visible on the upper left of the picture.

Additional pictures of this area.

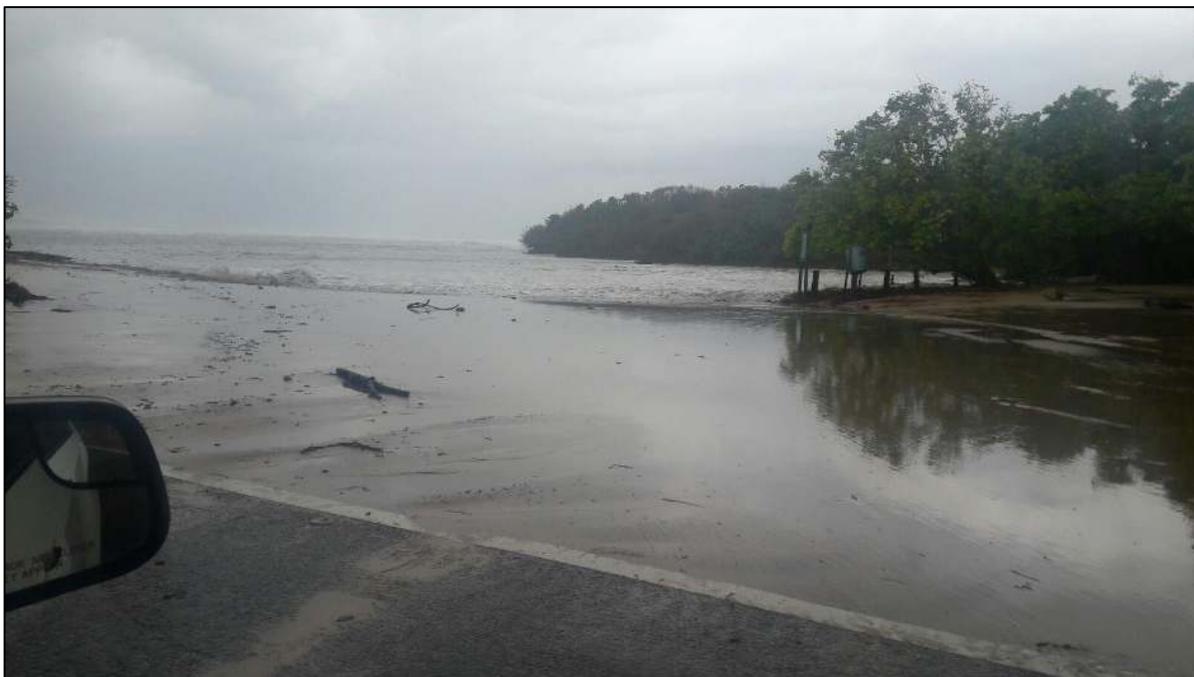
This unprotected beach leaves road PR-187 exposed to heavy wave action and flooding during strong storms. This area experienced heavy flooding during winter storm Riley (see below).
