Shoreline of Puerto Rico

PUERTO RICO COASTAL TYPES

COASTLINE AND BEACH ANALYSIS

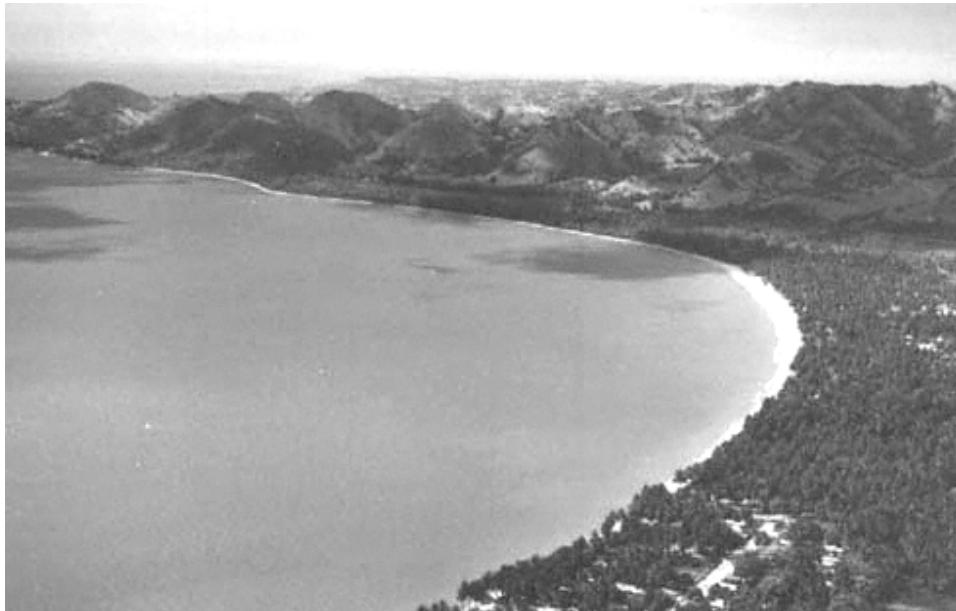
Figure 1. Volcanoclastic hills to the north and alluvial valley to the south are separated by the Great Southern Puerto Rico fault

From Aguadilla to Punta Cabo Rojo, the coast is dominated by the effect of the termination of structural mountain ridges separated by broad alluvial valleys (Figure 1). The ridges form a rocky coast, and the shoreline bordering the alluvial valleys is occupied by sand beaches.

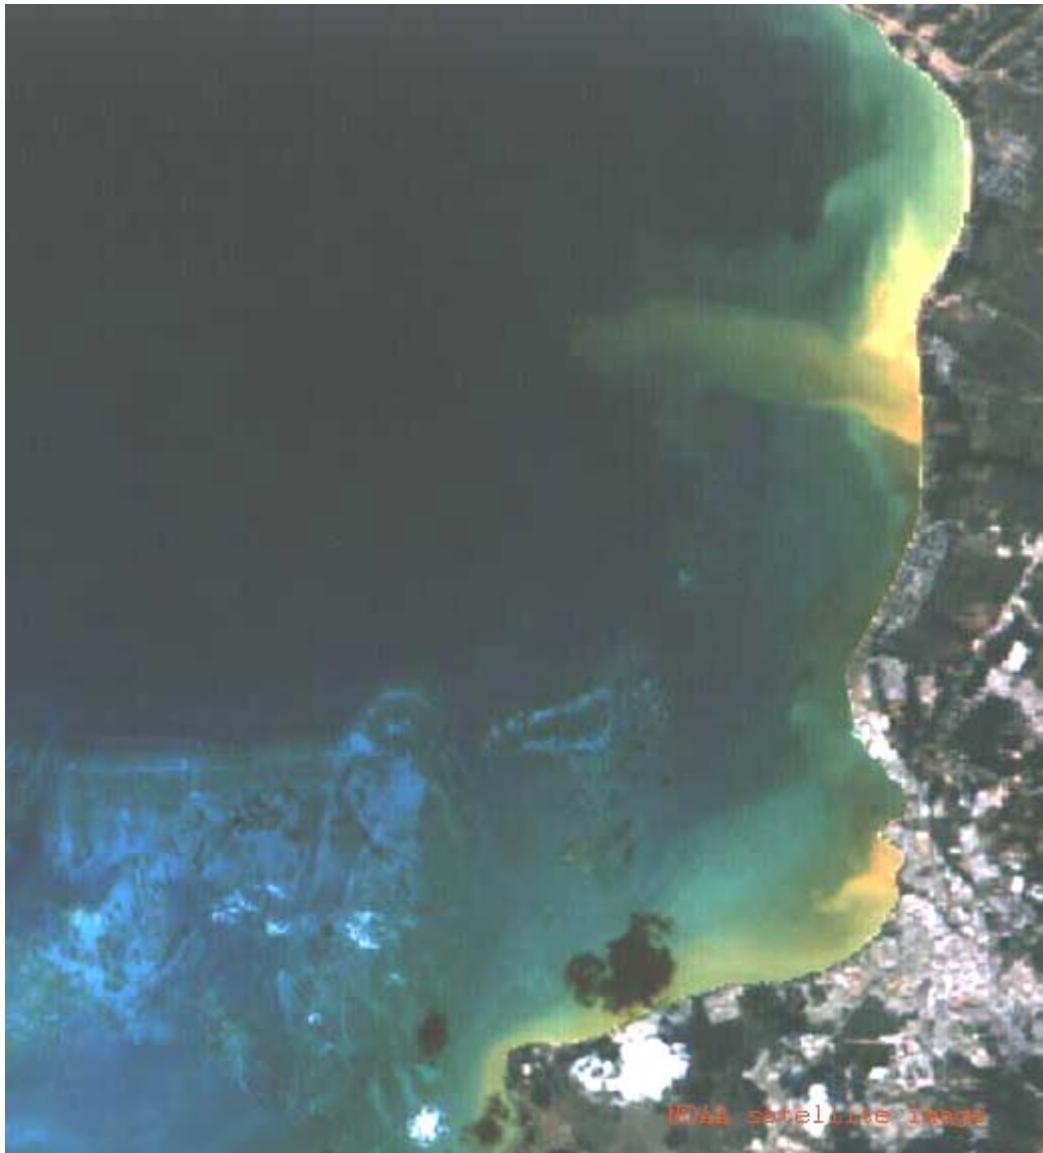
Figure 2. Narrow insular shelf off Mayagüez- Añasco bays and wide carbonate shelf off Punta Guanajibo and south

South of Mayaguez, The shelf is relatively broad and reefs and shoals with depths of less than 10 meters extend 20 kilometers offshore (Figure 2). The same pattern of ridge with rocky shoreline and valley with sand beach is present, but there are also areas of mangrove coastline and fringing reef coast because of the protection offered by the shoal continental shelf area.

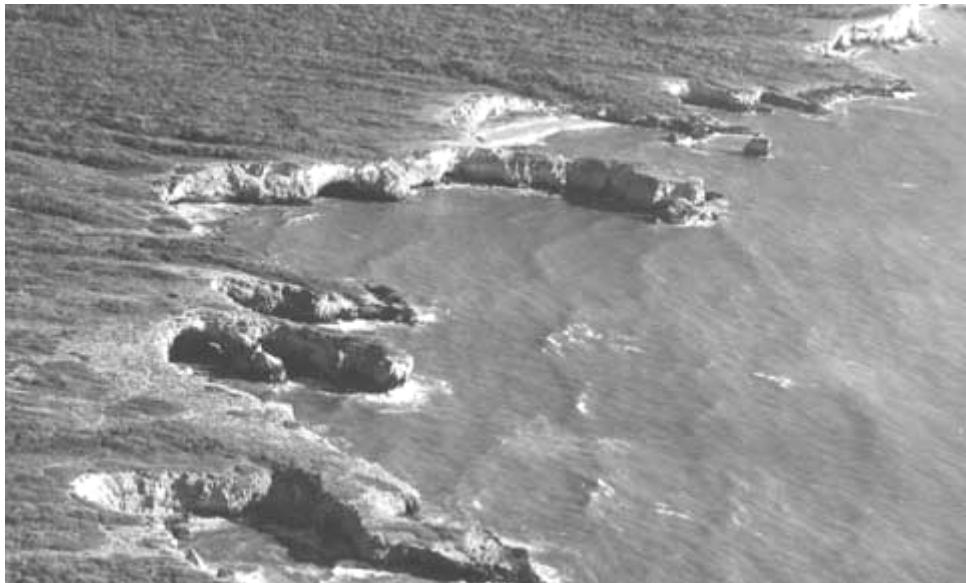
Figure 3. Irregular shoreline from wave action on south coast limestones

The southwest coast is very irregular, with projecting brush- covered points of limestone between shallow coves and bays (Figure 3). There are fringing reefs along part of this coast. Except for the eastern and western ends of the south coast, and the Guánica area, the land is generally low near the shore.

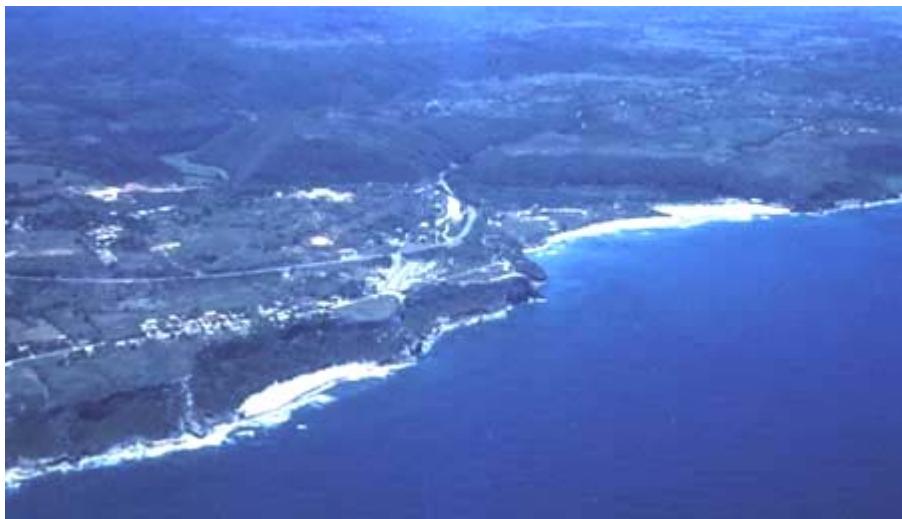
Figure 4. Rocky north coast, massive limestone

The shoreline development is closely related to whether the adjacent land area of the coast is Cretaceous-Tertiary limestones, igneous rock, or low Tertiary sediment fans and alluvial plains. The limestone outcrops generally form a rocky coast with small, very local sand or gravel beaches (Figure 4). In many places, this type of shoreline has been altered by the growth of mangrove and the subsequent development of a mangrove shoreline (Figure 5).

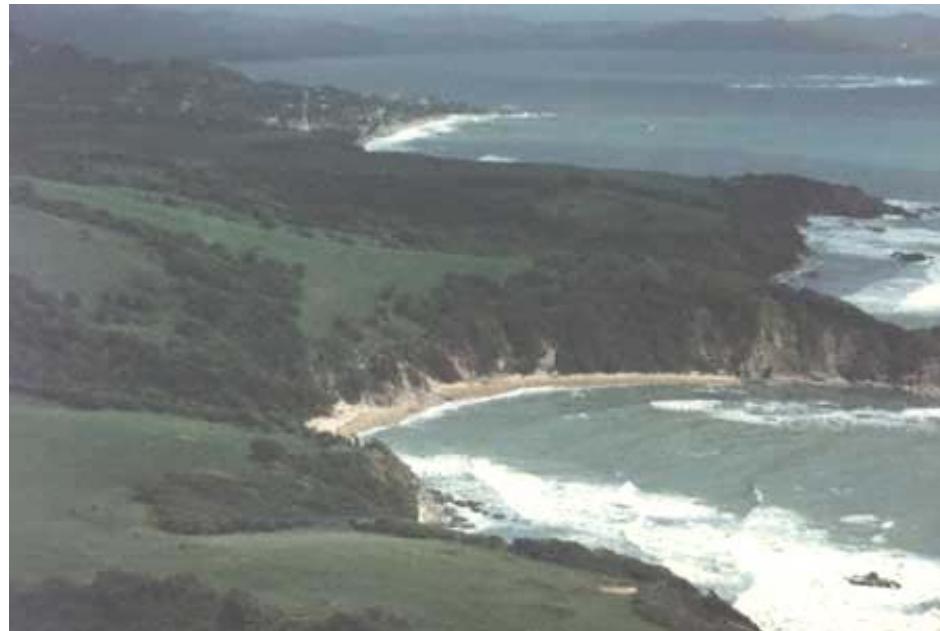
Figure 6. Rocky bluffs with small beaches, southeast Puerto Rico

The southeast coast of Puerto Rico is mainly rocky coastline with some broad beach under the attack of strong wave action areas developed in front of alluvial valleys and a few areas of fringing reef coastline. This pattern extends along most of the east coast where irregular projecting rocky bluffs separate numerous small shallow coves and bays (Figure 6). In these areas, as on the west coast, the hills are within a mile of the coast. Shoal water extends offshore as part of the platform connecting Puerto Rico and the Virgin Islands.

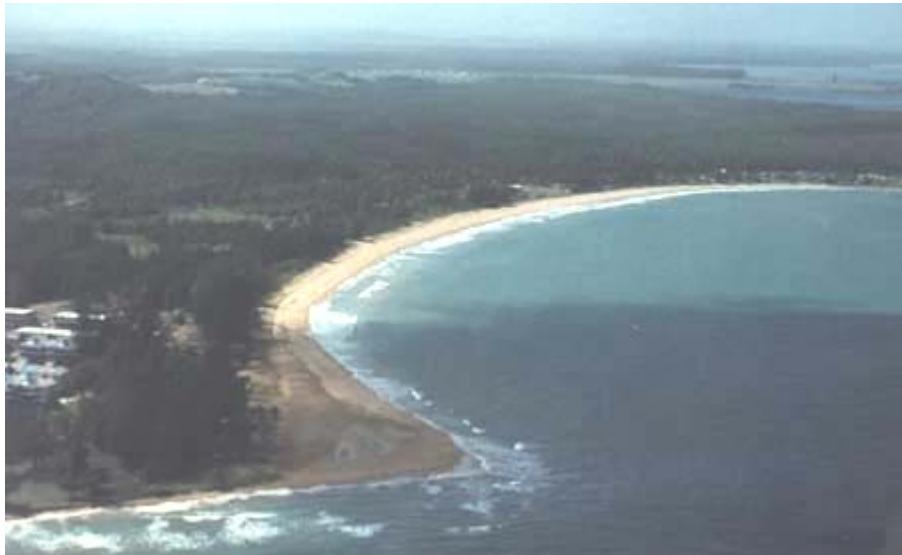
Figure 7. Low coastal plain with sandy beach

There is fairly widespread mangrove coast along the northern half of the east coast. The north coast from the east end of the island to San Juan is low and sandy (Figure 7) except for occasional eolianite bluffs (Figure 8).

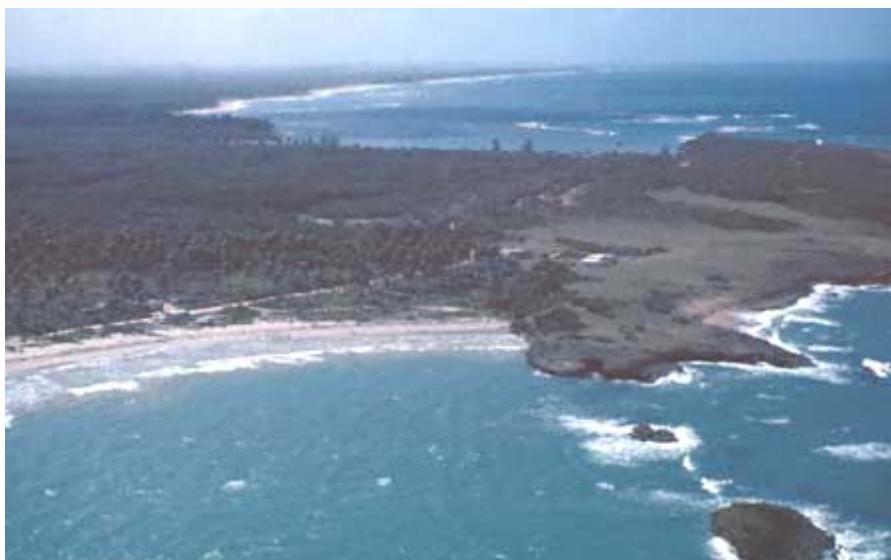
Figure 8. Eolianite bluff, Vacia Talega

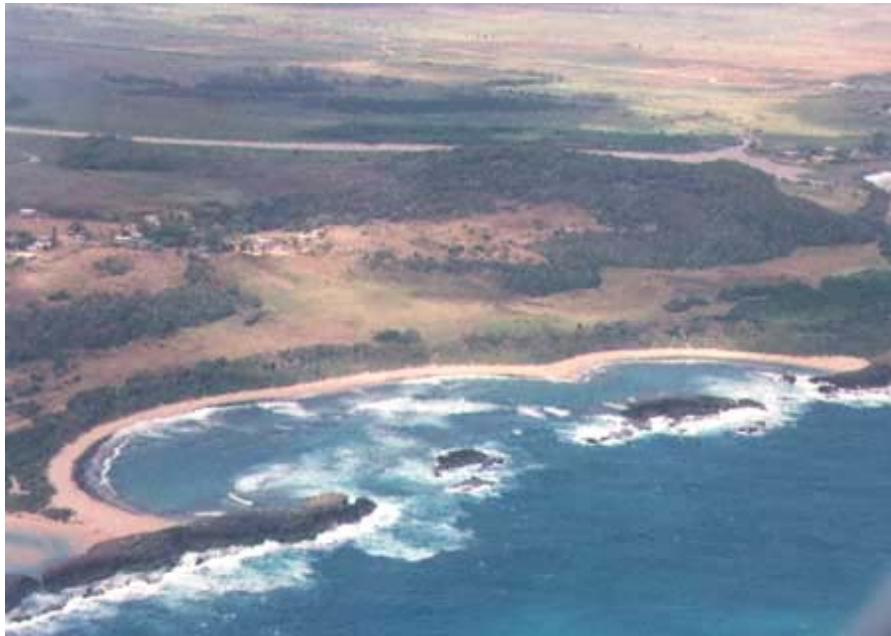
Figure 9. Coastal plain north of Manati

From San Juan to Arecibo, the coast lies in front of a low-lying coastal plain (Figure 9). Beach sand, cemented dunes, beach rock, and mangrove swamps dominate this region. There are sandy beaches and dunes with occasionally rocky eolianite coast and beach rock coast from San Juan to Vega Baja. The mangroves lie close to shore on the coastal plain but do not form the coastline along any part of the northern coast. From Vega Baja to Arecibo, the coast is dominantly eolianite with numerous small lunate

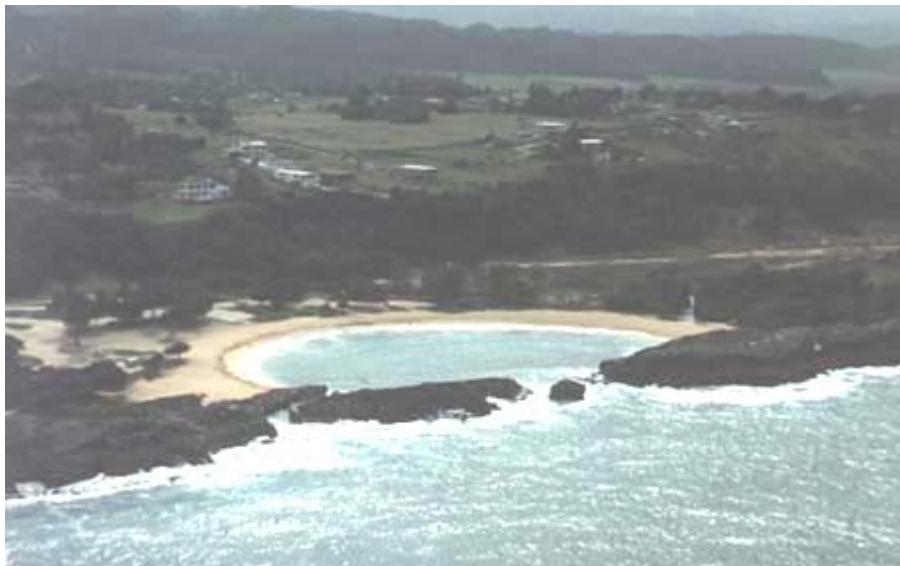
Figure 10. Lunate bays are common on north coast – Marchiquita

bays bordered by beaches (Figure 10). There is some movement of the beach sand from one bay to another behind the eolianite ridges.

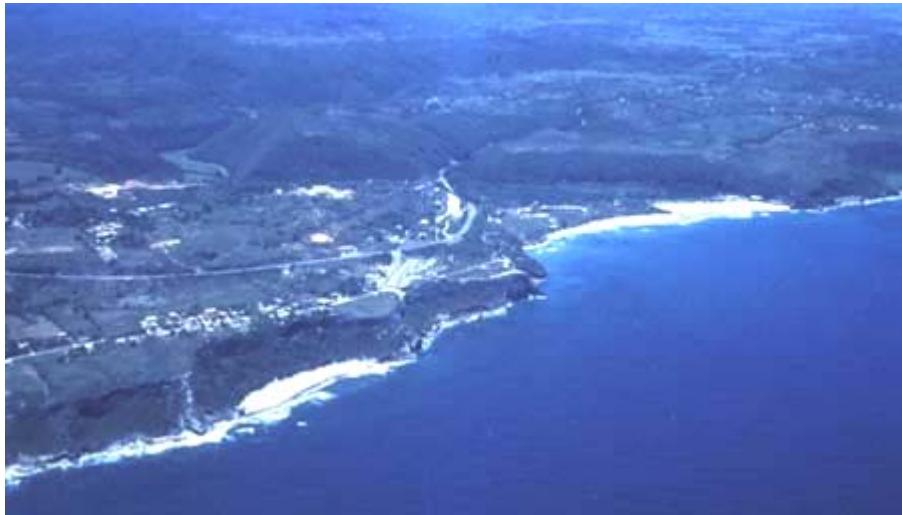
Figure 11. Rocky cliffs and beaches, north coast

The north coast from Arecibo to Aguadilla is a series of rocky cliffs with sand beaches and dunes between them (Figure 11). The prominent features are the high hills in the interior and high cliffs along the coast. Where low coastal plains with beach are present, they are less than a kilometer in width.

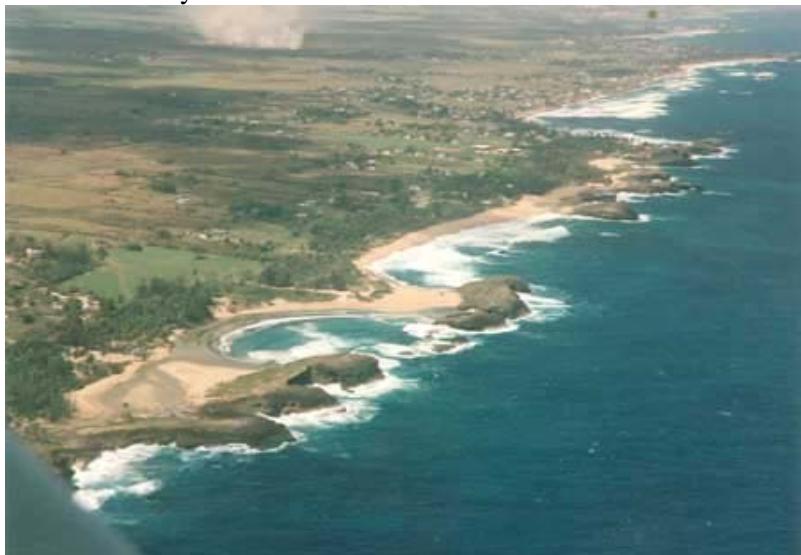
Figure 12. Restricted communication between beaches

The coastal zone of Puerto Rico is remarkably diverse. Unlike the shorelines of many major continents, there are no long interrupted stretches of basically similar beach. The beaches of Puerto Rico are relatively short and are divided into separate and distinct beach systems that have restricted communication with one another (Figure 12). Each is a closed or semi-closed unit receiving its supply of sediment from limited local sources and transmitting little of its longshore moving sand to another beach system. In analyzing the sand and beach systems to determine the extent of isolation, mineralogy, metal content and biogenic constituents have been studied; also the actual physical parameters of separation have been analyzed.

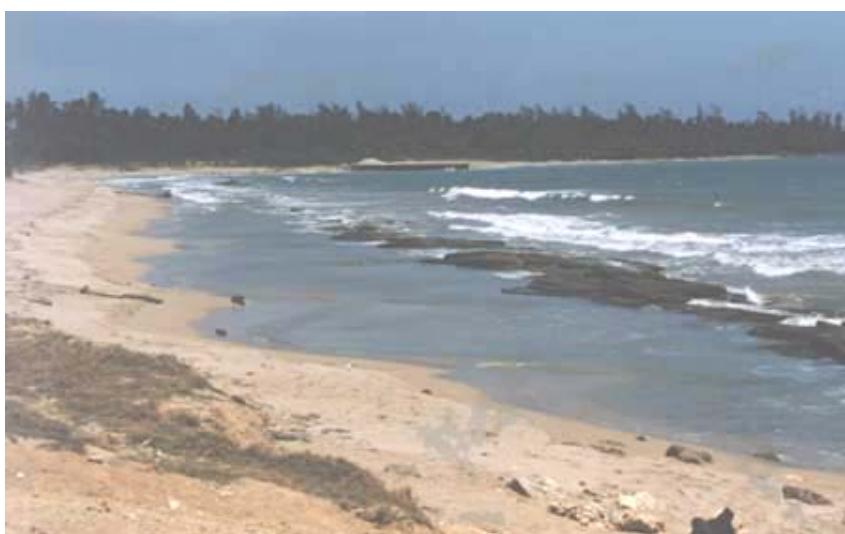
Figure 13. Beachrock at Levittown

The eolianites and beachrock along the north coast of Puerto Rico form a relatively continuous barrier which protects the shore. Behind this protection, lagoons, tombolos, and other depositional features have formed. This protection is being breached and removed by the natural force of the waves. Where the eolianite is breached, erosion has cut into the land to form lunate bays. Because eolianites on the north coast are loosely cemented, they are being reduced in height and are being destroyed, allowing waves to penetrate to the beaches with greater force. This has upset the established equilibrium and caused retreat of the shore and erosion of the beaches. Beachrock is separated from the coast by tens of meters in many places, indicating recent erosion (Figure 13).

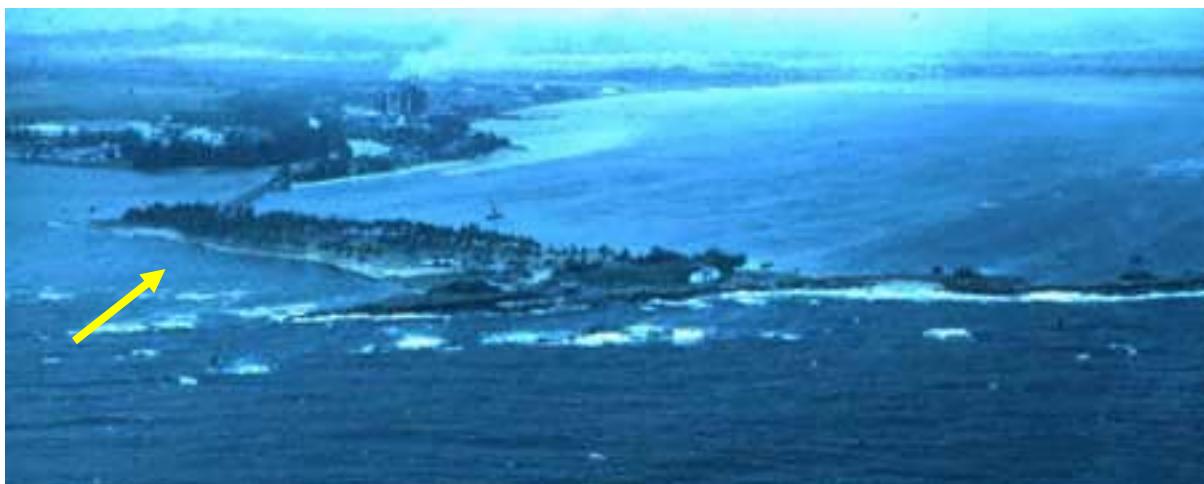
Figure 14. Isla Cabras causeway

Human activity is important locally. The activities of man have been varied and striking in contributing to the loss of coastal areas. In some cases the natural transfer of sand from one area to another has been blocked by the construction of new structures such as the causeway between Punta Tocones and Isla de Cabras (Figure 14). This has not only cut off a source of sand nourishment, but has altered the prior circulation patterns, and tombolo of Punta Salinas is now being eroded (Figure 15).

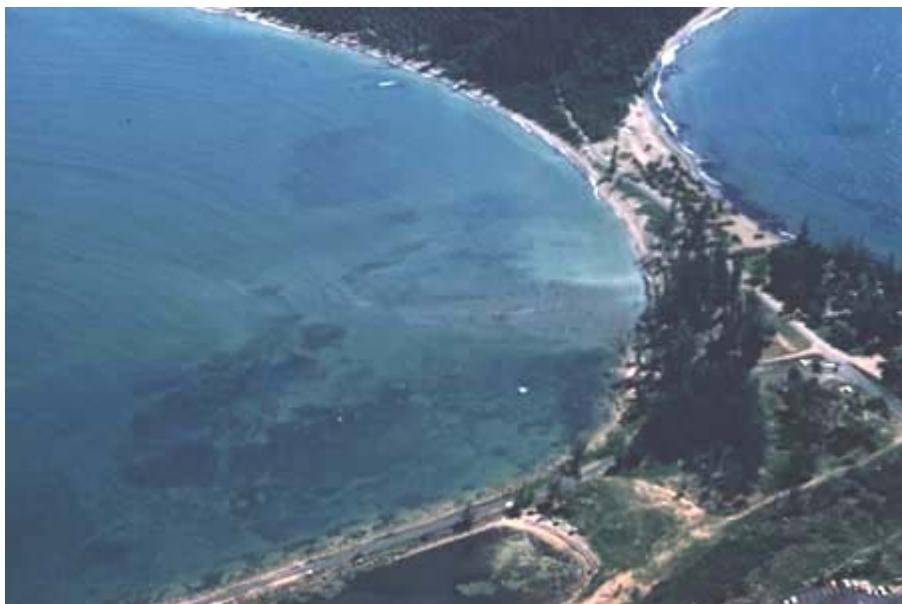
Figure 15. Eroding Pta. Salinas tombolo, Levittown

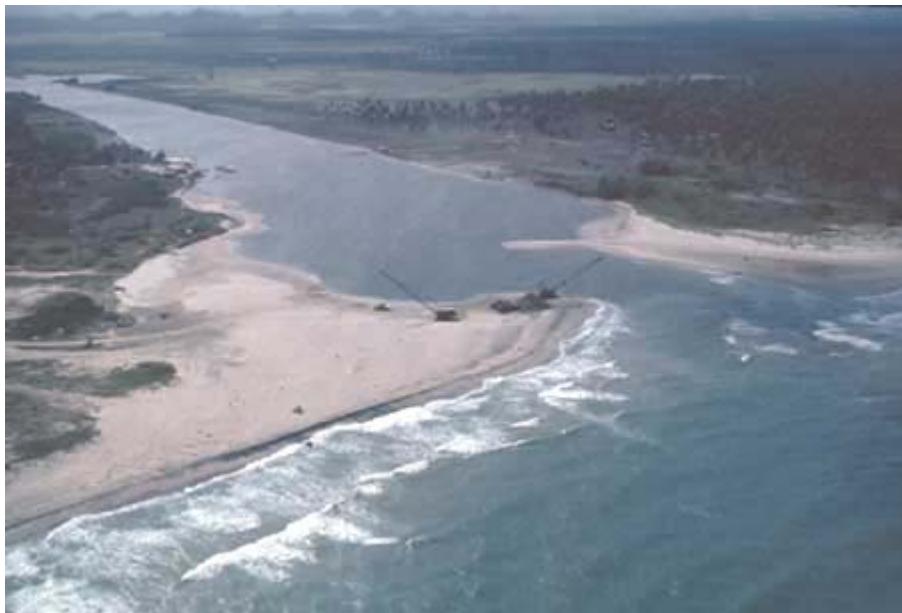
Figure 16. Removal of sand from the mouth of the Loiza River

Removal of sand from river mouths includes the collection of littoral drift sand and results in erosion such as that seen near the mouths of the Anasco and Loiza rivers (Figure 16). Removal of sand dunes and beach sand for use as fill and aggregate have certainly contributed to the depletion of many beach systems. In areas where sand dunes have been removed, leaving only a small barrier, waves have started to break over the barrier and are carrying sand away (Figure 17).

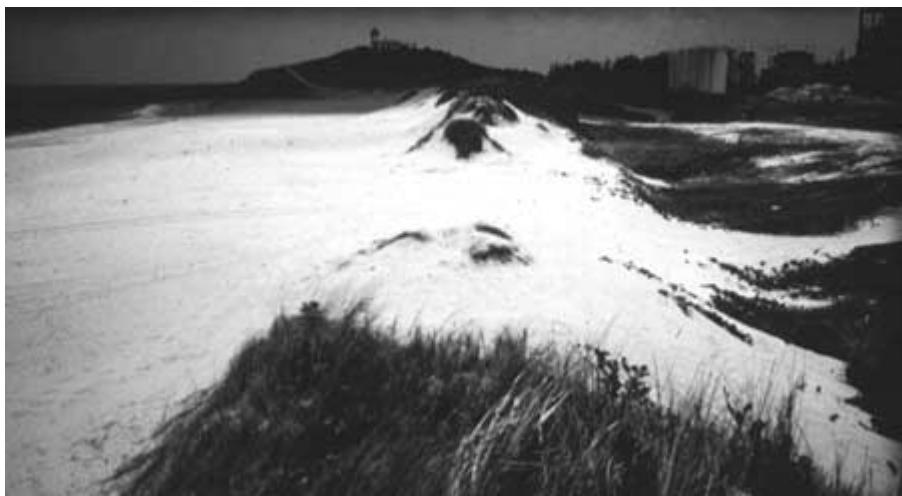
Figure 17. Breaching of north coast sand dune

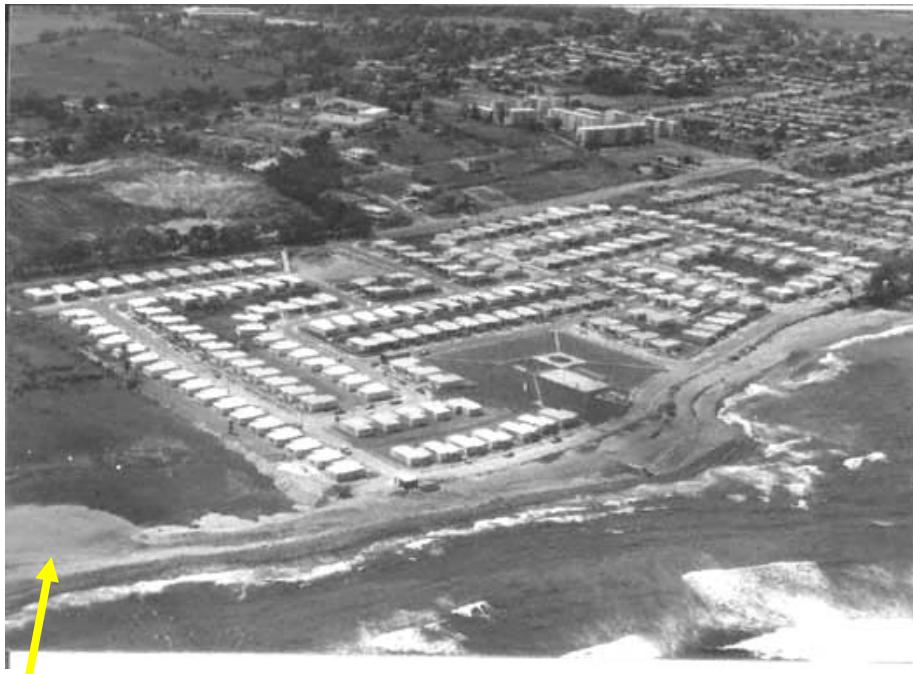
Figure 18. Urbanization of the shoreline. Note incursion of the beach east of the construction

Construction activities have crowded close to the shoreline because of limited land areas and reduced construction costs on the low coastal plain (Figure 18). This has not only aggravated the erosional process, but has put valuable new property in areas of natural erosion. This has in turn created the need to institute urgent and expensive protective techniques to protect the investment. These remedies may have effects not immediately recognized.

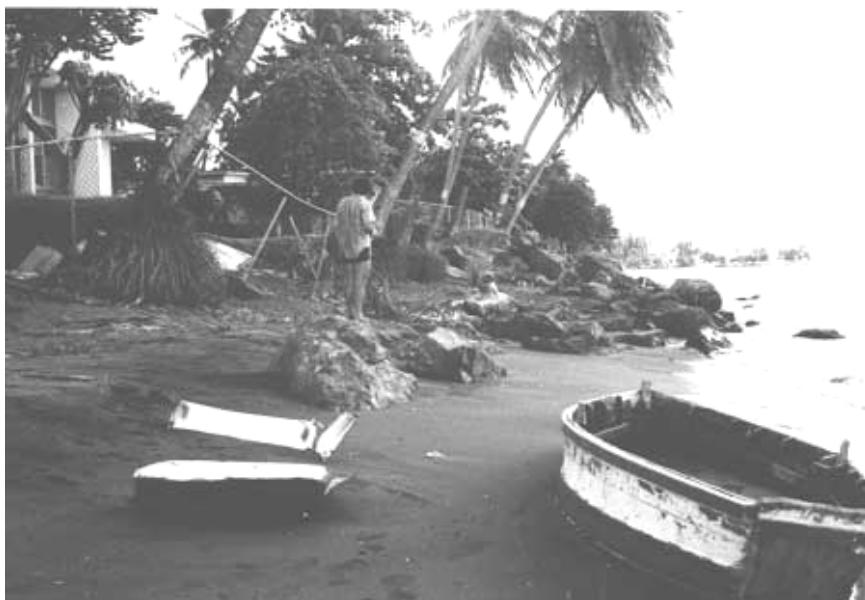
Figure 19. Armoring the shoreline with boulders and tires

Construction close to the beach south of Mayaguez Harbor was being rapidly endangered by erosion. Riprap was emplaced to protect this property, which then cut off a source of sand – natural coastal erosion – from the area to the south. The next step was riprap protection for houses to the south which were being threatened by the erosion generated by the riprap. As the problem moved south the entire beach was eventually replaced with riprap. The coast is now stabilized, with a basic change in coastal classification from sandy beach to rocky shoreline, man-made (Figure 19).

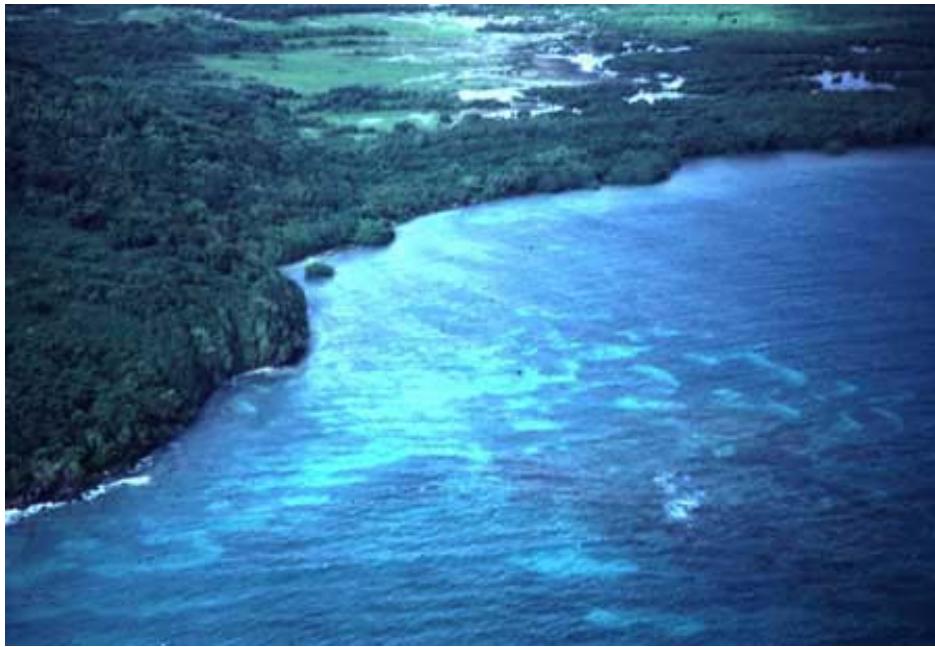
Figure 20. Mangrove shoreline Ceiba

The southern part of Medio Mundo is a mangrove coast and the northern part is beach plain. North of Quebrada Aguas Claras, there is a short mangrove coast and then northward a rocky shoreline to Punta Barrancas. From here to Playa de Fajardo the coast is mangrove (Figure 20).

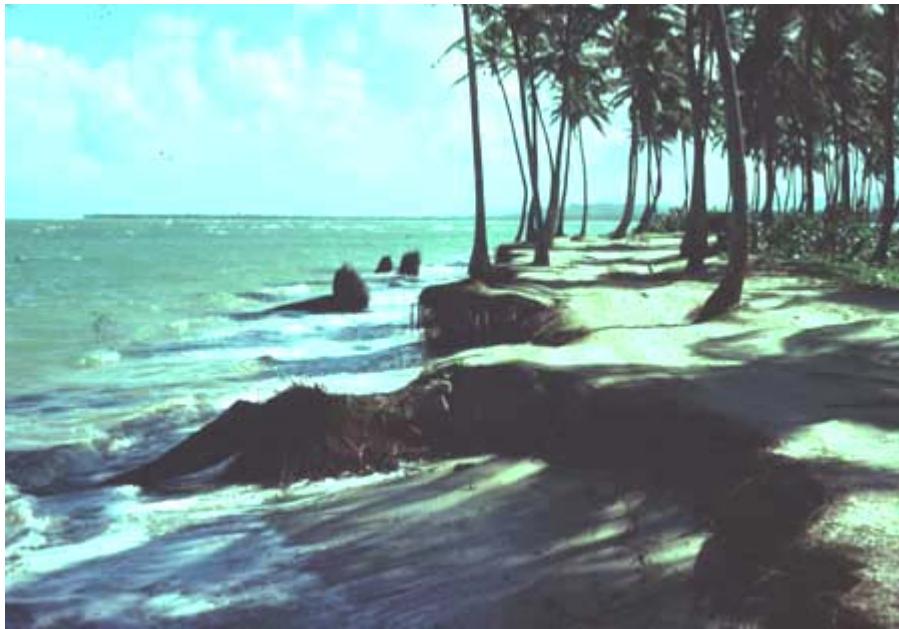
Figure 21. Coastal erosion at Pta. Iglesia

Between Punta Uvero and the Loiza River, there are several areas of erosion. Just east of Punta Uvero to Rio Herrera and east and west of Punta Iglesia and Punta las Carreras there is erosion (Figure 21). In both cases, this is strikingly shown by palm trees in the ocean, many of them lying at the water's edge.

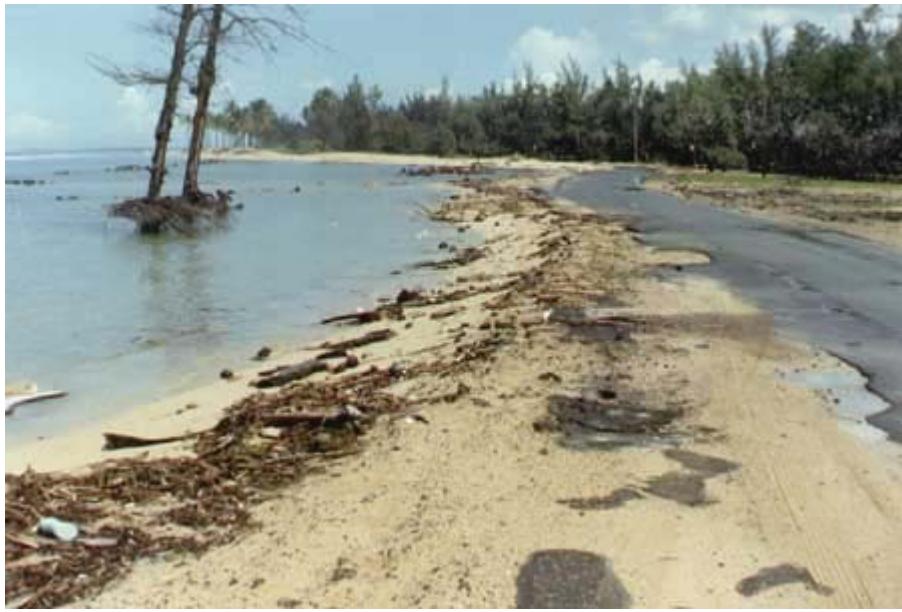
Figure 23. Erosion at Punta Madonado

short, narrow beach between Punta Maldonado and Punta Cangrejos. Erosion is severe on this beach (Figure 23).

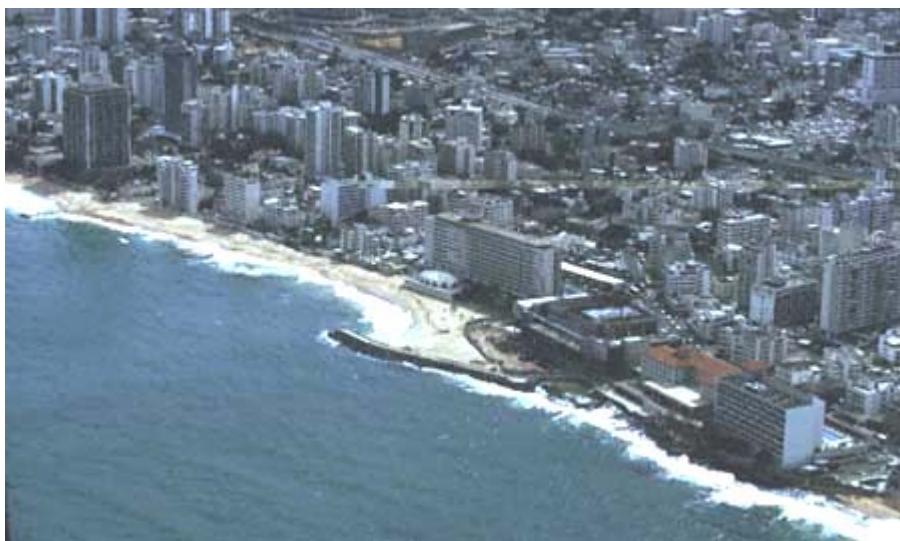
Figure 24.

indicate that there is probably transference of material from one beach to another resulting in essentially one beach system. The addition of a groin at La Concha has interrupted the westward migration of sand (Figure 24). There are sand deposits in deep water (40-50 meters) off Boca Cangrejos which may result from the offshore transport of the beach sands.

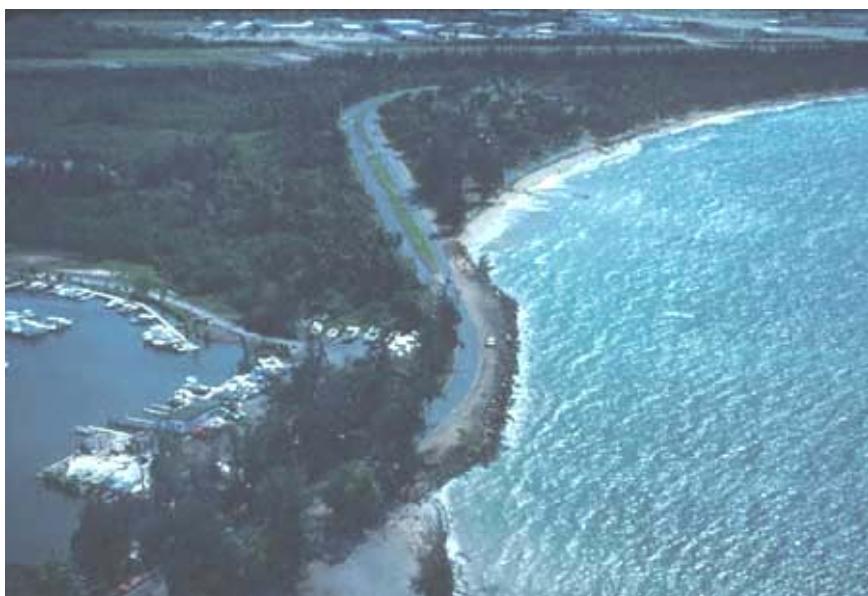
Figure 25. Armored shoreline (boulder riprap) at Cangregos

The beaches are thin coverings of sand over a rocky shoreline. Erosion at Boca de Cangrejos has threatened the road. The remedial action has been emplacement of rip-rap (Figure 25). There is active erosion at Ocean Park and Isla Verde. There is loss of sand offshore and also windblown into the streets in the Condado area. Although the composition of sand on Isla Cabras is similar to the San Juan beach system, there is probably no transport of sand across the deep entrance channel of San Juan Harbor.

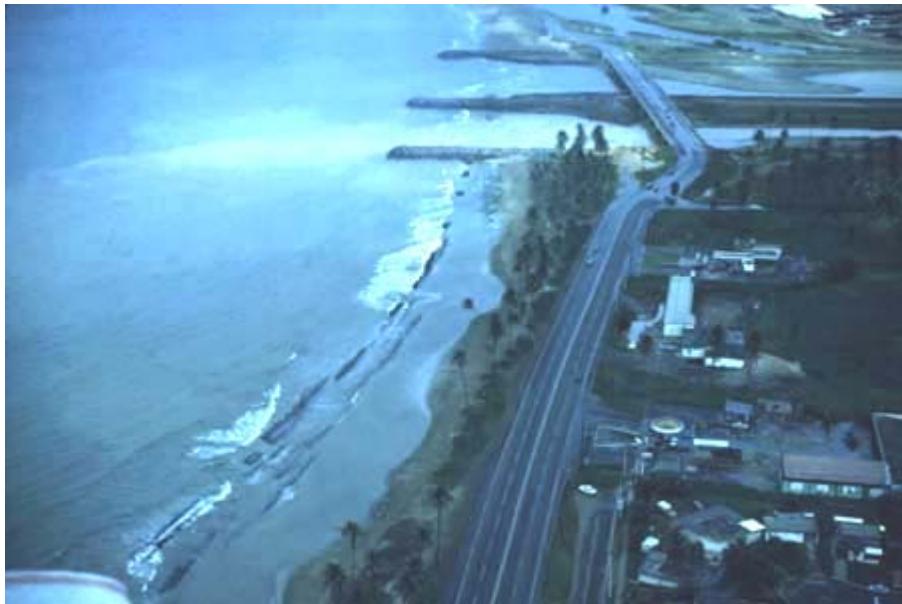
Figure 26. Erosion of shoreline at Levittown has left beachrock offshore

Figure 27. Riprap on east side of Pta. Salinas tombolo

From Levittown to Rio de la Plata, the beach is dominantly igneous rock fragments with other dark minerals, quartz, feldspar, and carbonate grains. There is erosion at Levittown and Palo Seco (Figure 26). The erosion of sand from behind the beachrock at Levittown is fairly recent and shows the rapid changes in beach position since the construction of the Isla Cabras causeway and the Bayamon canal. This construction has drastically altered the current and wave patterns and set up new conditions in the large lunate bays between Isla Cabras and Punta Salinas. Punta Salinas is a tombolo of fairly recent origin that is now being eroded (Figure 27).

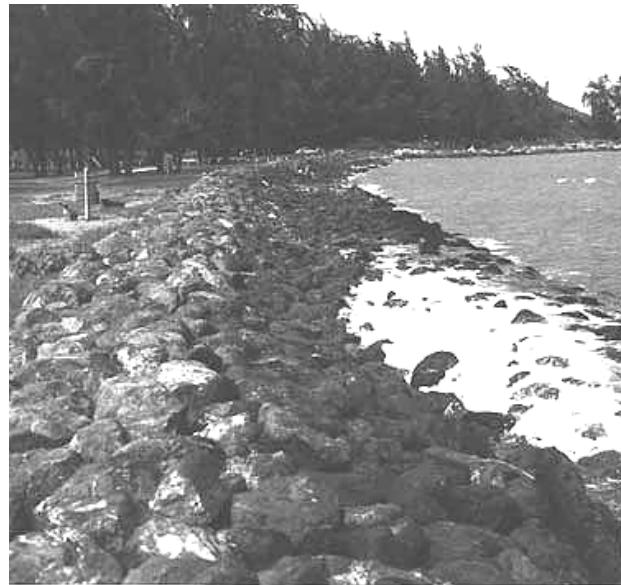
Figure 28. Meanders cut off by encroaching shoreline at Cocal

have been cut off by the retreating beach line (Figure 28). There is severe erosion just west of Punta Corozo that has been partially controlled by riprap to protect the highway (Figure 29).

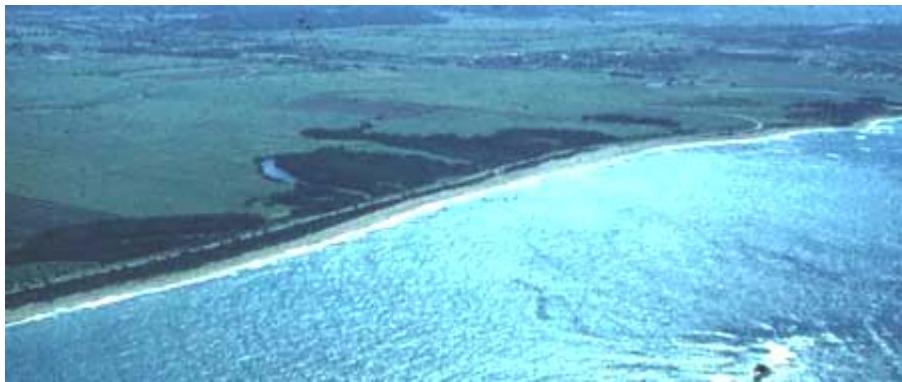
Figure 29. Highway armored with boulders

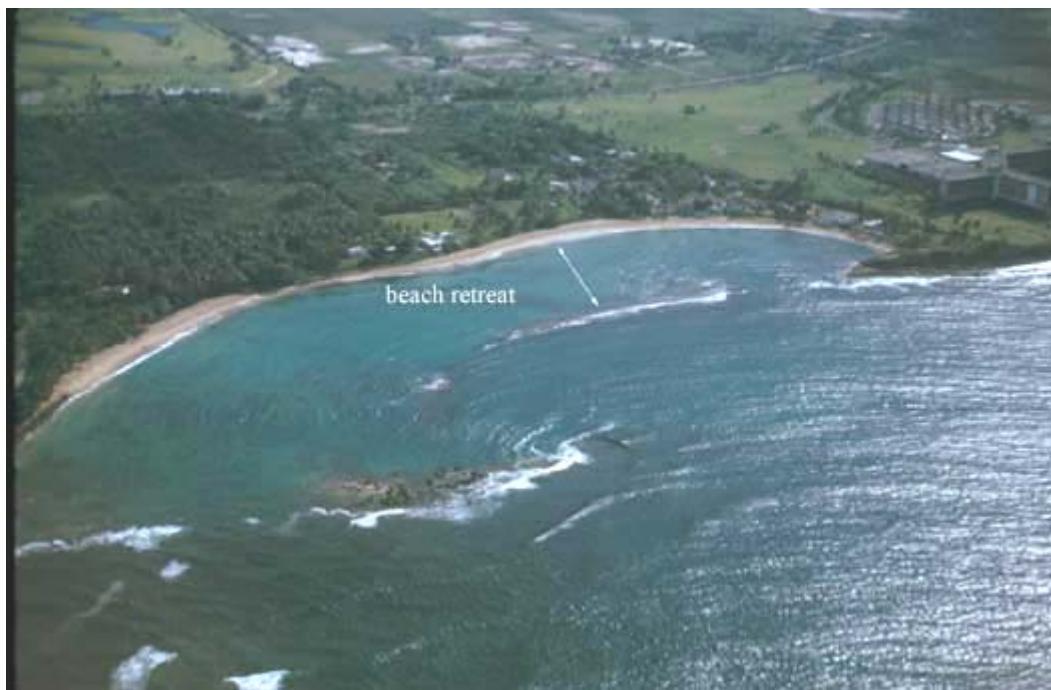
Figure 30. Offshore beachrock shows shoreline erosion.

From Boca Juana to Rio Cibuco, the sands are dominantly carbonate with some quartz, except for the Cerromar Beach. This is a man-made beach, nourished by truck with quartz sand. The high level of quartz in the next beach west shows that sand transport and bypassing occurs. There is erosion at Sardinera beach evidenced by the continuing loss of palm trees at the shoreline. There is an input of dark minerals and igneous rock fragments by the Cibuco River. There is also erosion in the bay west of the river mouth. The shoreline in this area is beachrock and is separated from an earlier shoreline by a widening expanse of water (Figure 30). The interference of refracting and defracting waves behind the isolated eolianite creates zone in which sand is deposited to form a tombolo.

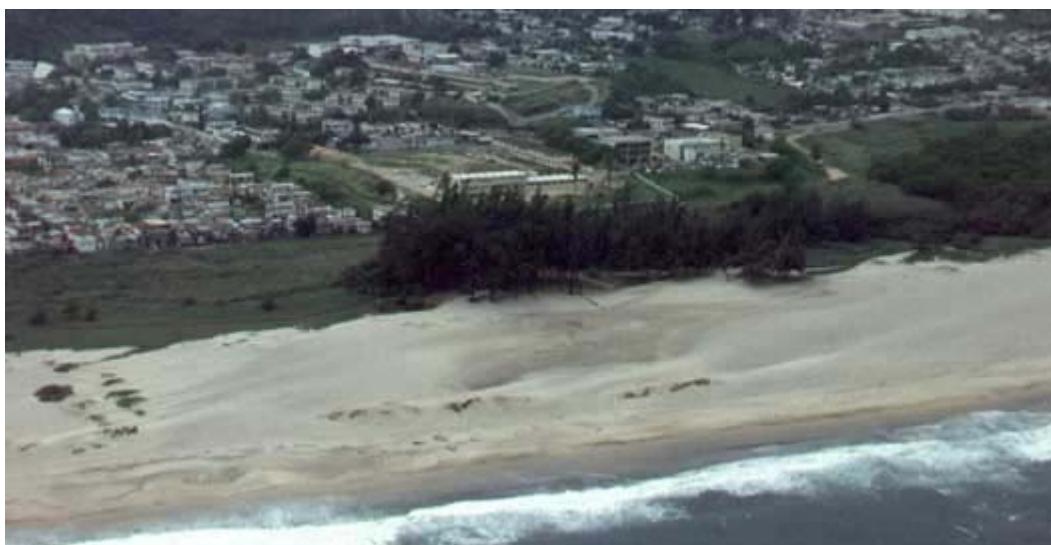
Figure 31. Inshore migration of beach sand – dune system

Near Islote, part of the beach sands are being lost from the system by wind erosion (Figure 31). The sands are being incorporated into dunes behind the beach, and evidence of recent activity is shown where the sand has blown over the vegetation.

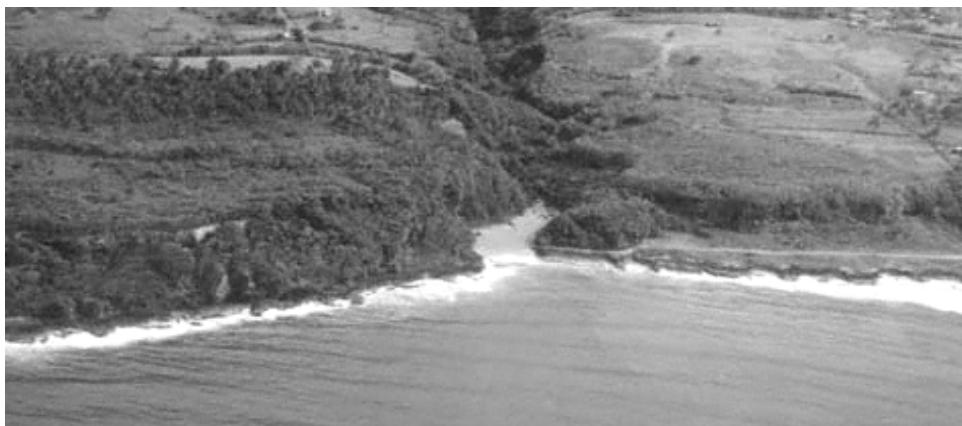
Figure 32. Pocket beach at Bellaca

The beach at Bellaca is a small local sand accumulation or pocket beach (Figure 32). Most of the beach material is carried to the area by the quebrada. The Guajataca beach is quartz, feldspar, and igneous rock material carried to the area by the Rio Guajataca. It is isolated from the other beaches by rocky headlands (Figure 33). The beaches east of Isabela are generally narrow, thin veneers of sand over a rocky shoreline (Figure 34).

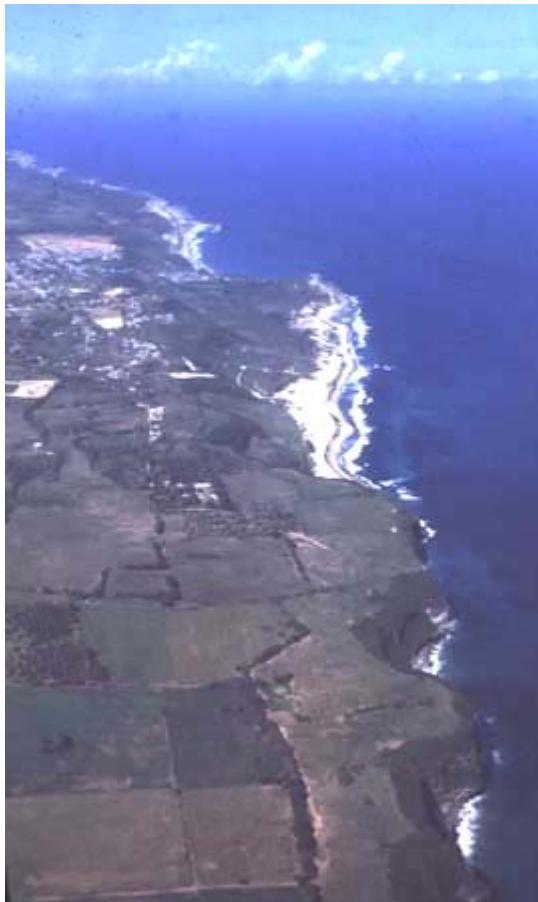
Figure 34. Rocky shoreline, northwest coast

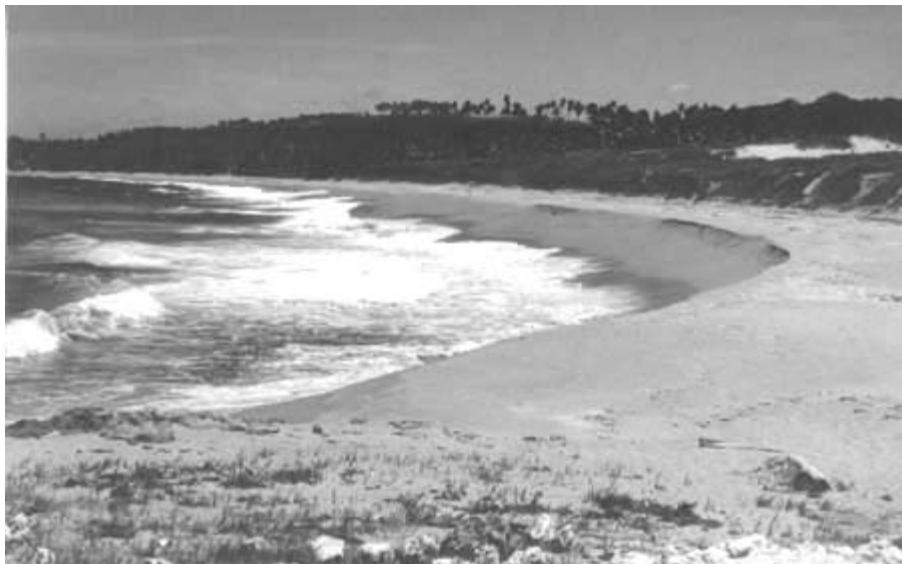
Figure 35. Punta Jacinto east beach

The dunes behind the beaches have been extensively mined for sand, and in places (Sardina) the beach sands have been removed. The beach at Punta Jacinto (Figure 35) shows the wide and thick accumulation of sand that lies in front of the vegetation covered sand dunes. West of Jobos beach, there has been major removal of the dune sands (Figure 36). Both the composition of the beach, and the presence at the lower part of the beach of beachrock outcrops suggests that the major source of beach sand is the dune system.

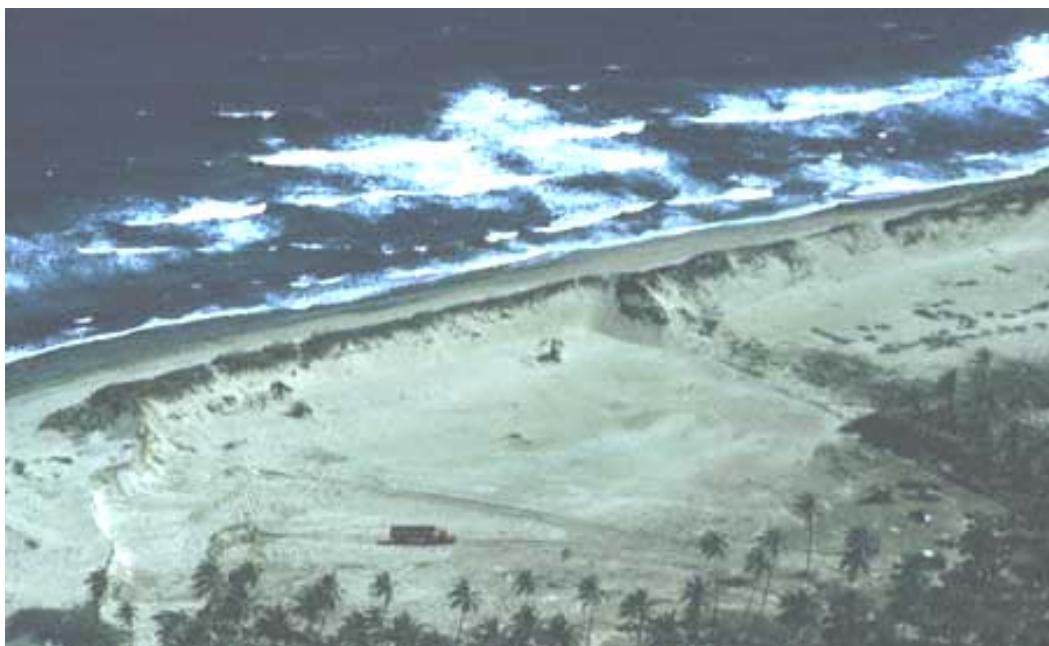
Figure 36. Sand dune mining near Punta Jacinto, northwest coast

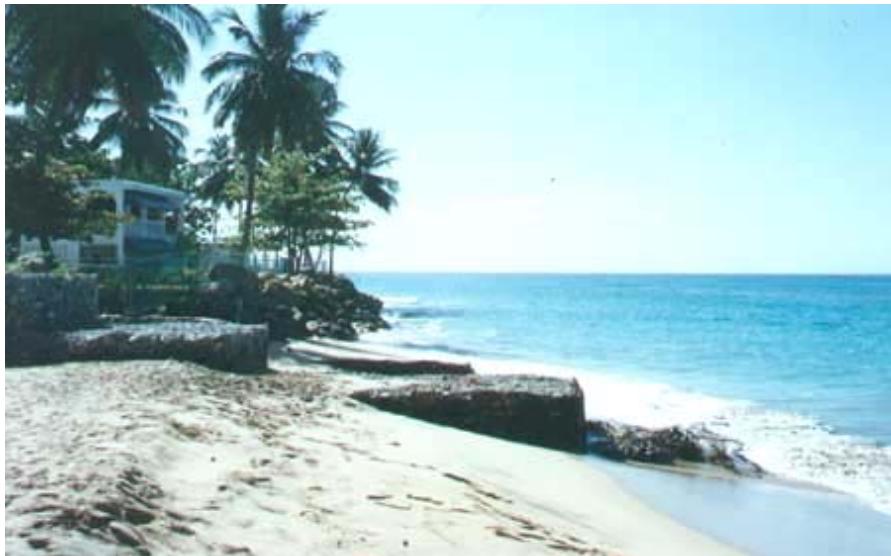
Figure 38. Beach erosion at Ríncon

There is erosion from Rio Culebrinas to Punta Gorda. The beach sediments are approximately equal parts carbonate shell material, quartz and feldspar, and igneous rock fragments. Sediments from a large drainage basin are carried to this part of the coast by Rio Culebrinas and Rio Grande. There is strong littoral drift to the southeast, but no evidence of severe erosion except near Ríncon (Figure 38).

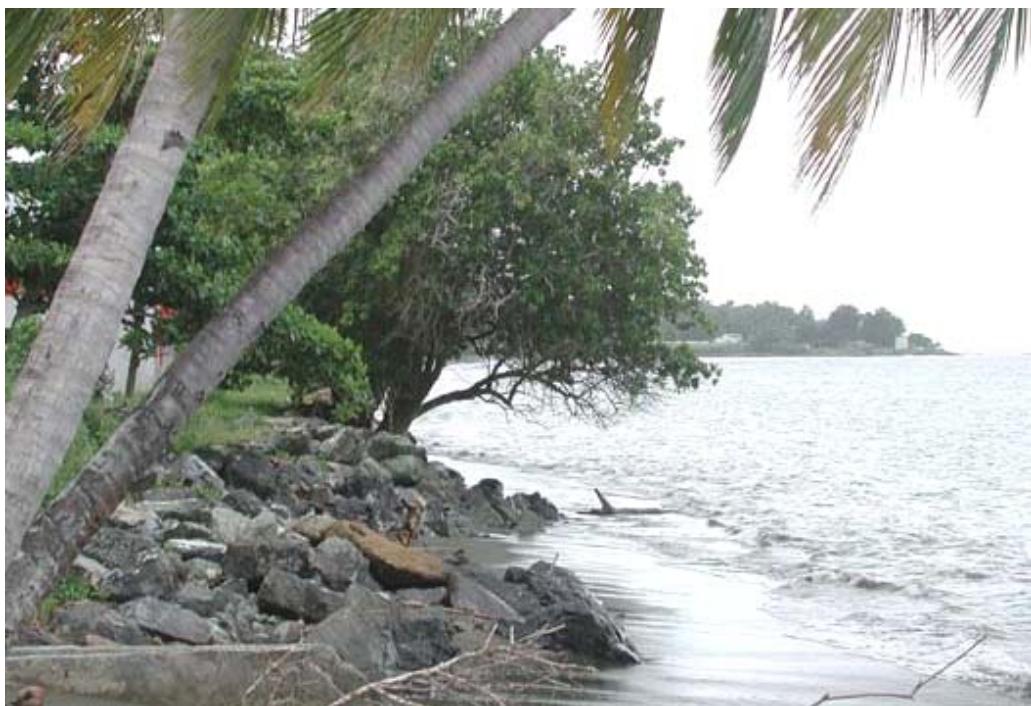
Figure 40. Riprap shoreline, San Jose

There is erosion along the southern half of Mayaguez beach. Riprap has been added to long stretches for protection until the coastline is no longer beach (Figure 40). This has slowed the loss, but has also shifted the erosion to another part of the beach until riprap now extends to the Guanajibo River. The September 1975 flood made major alterations to the beach and ripped out both highway and riprap . Prior to the flooding, the severity of the beach erosion was shown by the undermining of homes on the beach (Figure 41). The flood carried large amounts of sand offshore. Some of these sands may return to the beach system, but most will be covered by the marine silts that are the dominant sediment beyond the three meter depth contour.
