Shoreline of Puerto Rico

PUERTO RICO COASTAL TYPES

COASTLINE AND BEACH ANALYSIS

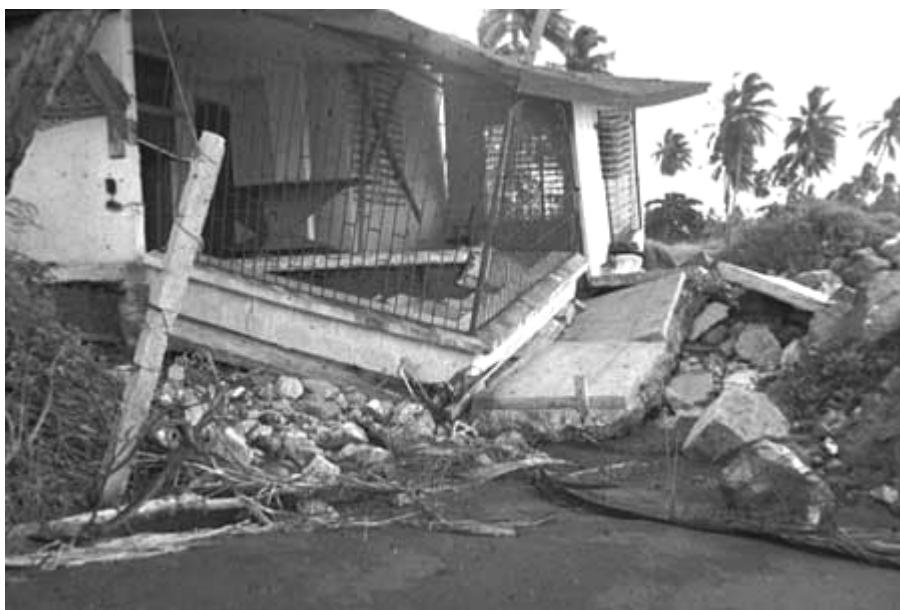
Figure 41. Undermining of house in San Jose

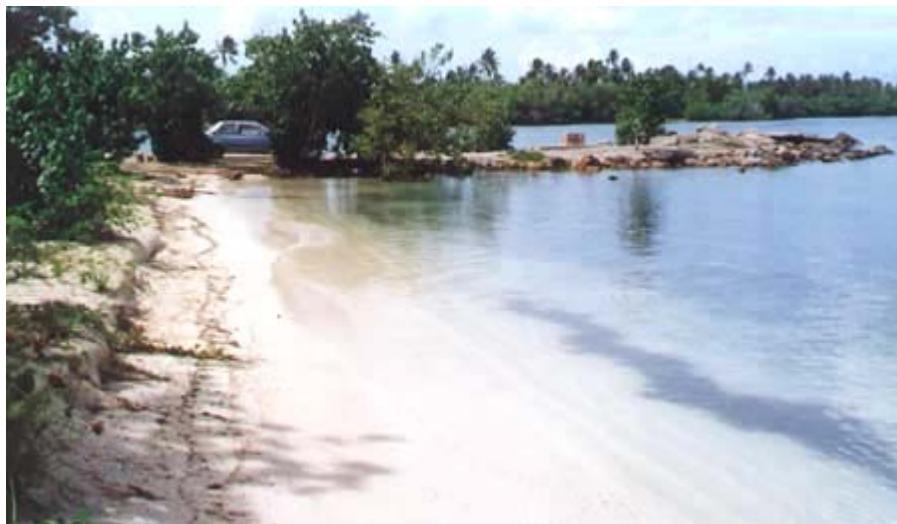
Figure 42. Ostiones beach – the sand is largely *Halimeda* plates and fragments

The beaches south of Punta Guanajibo are carbonate, quartz, and igneous rock fragments. Some of the terrigenous materials in the beaches north of Punta Arenas are passing the rocky Guanajibo Point and returning to the beach system. At Ostiones (Figure 42), the beach sands are 100 percent carbonate, dominantly *Halimeda* plates (calcareous algae). The sands at Boqueron beach are carbonate and quartz. The alluvial plains west of Boqueron are the source of the quartz grains. There is erosion at Punta Arenas, Punta la Mela, and southwest of Boqueron Beach.

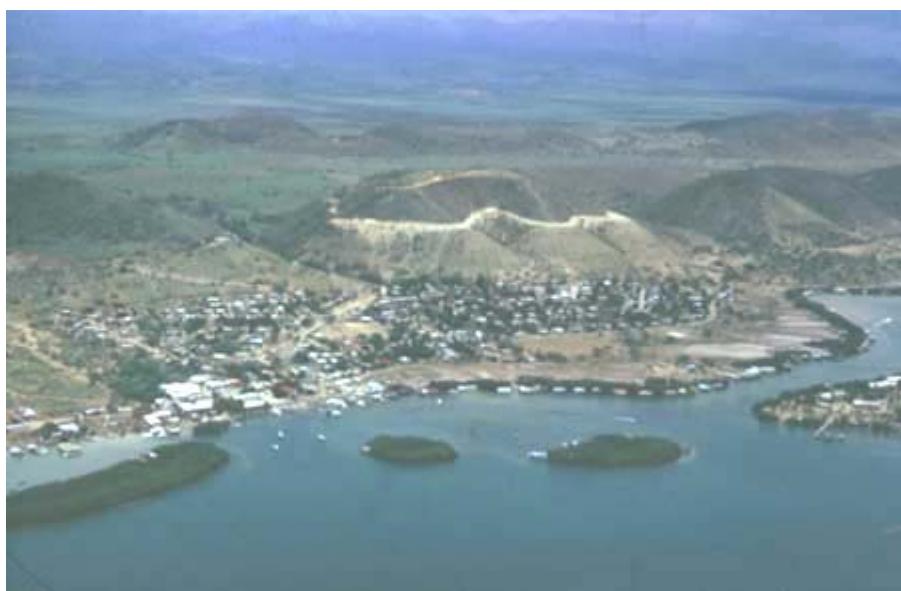
Figure 44. The hills behind La Parguera are southward dipping limestones

At Parguera there is a tidal flat coastline behind fringing mangrove. The land immediately behind the coast is a low range of limestone hills that are the southern limb of a syncline (Figure 44). Isla Magueyes and Isla Matei are outcrops of this limestone. Visual observations, seismic surveys, and collected data show that the shelf south of La Parguera is underlain by the same limestone, and it has been suggested that the lines of offshore reefs may be localized by outcrops of the southern flank of the limestone syncline.

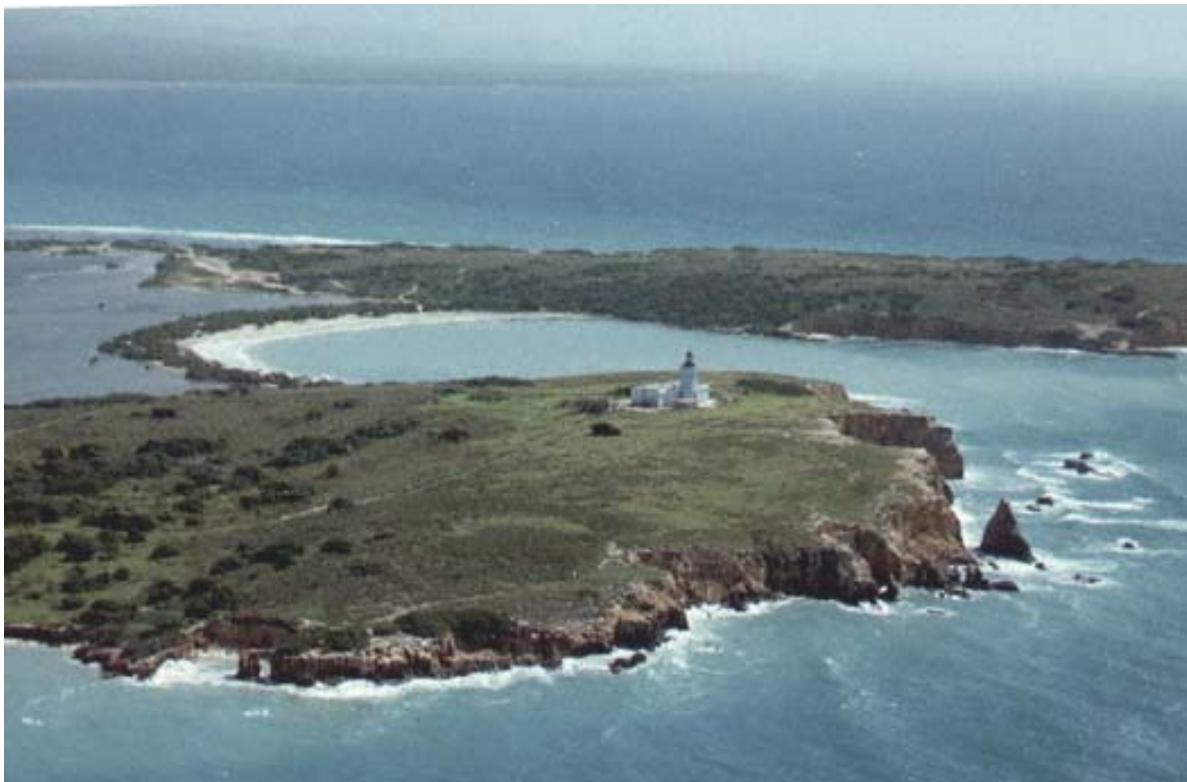
Figure 47. Small pocket beach between the two limestone outcrops

Cabo Rojo beach is a small pocket beach at the base of the limestone cliffs (Figure 47). It is composed of carbonate and quartz grains. Cabo Rojo is an outlier of the limestone forming the coast and is connected to the mainland by the deposition of a sand spit which joins the two. This has been used as an example of a tombolo. Playa Sucia is a carbonate and quartz beach that gets its name from the unique circulation patterns in the bay between Cabo Rojo and Punta Molino. As the surface currents move westward along the south coast of Puerto Rico, part of the flow passes Cabo Rojo and continues into the Mona Passage. Part of the flow is diverted into the bay and carries surface debris to Playa Sucia. The bay contains large quantities of sand which are being moved southwest past Cabo Rojo (Figure 48). Since the longshore drift is south from Punta Aguila, this sand is being moved out of the beach system and is a potential sand source for offshore mining.

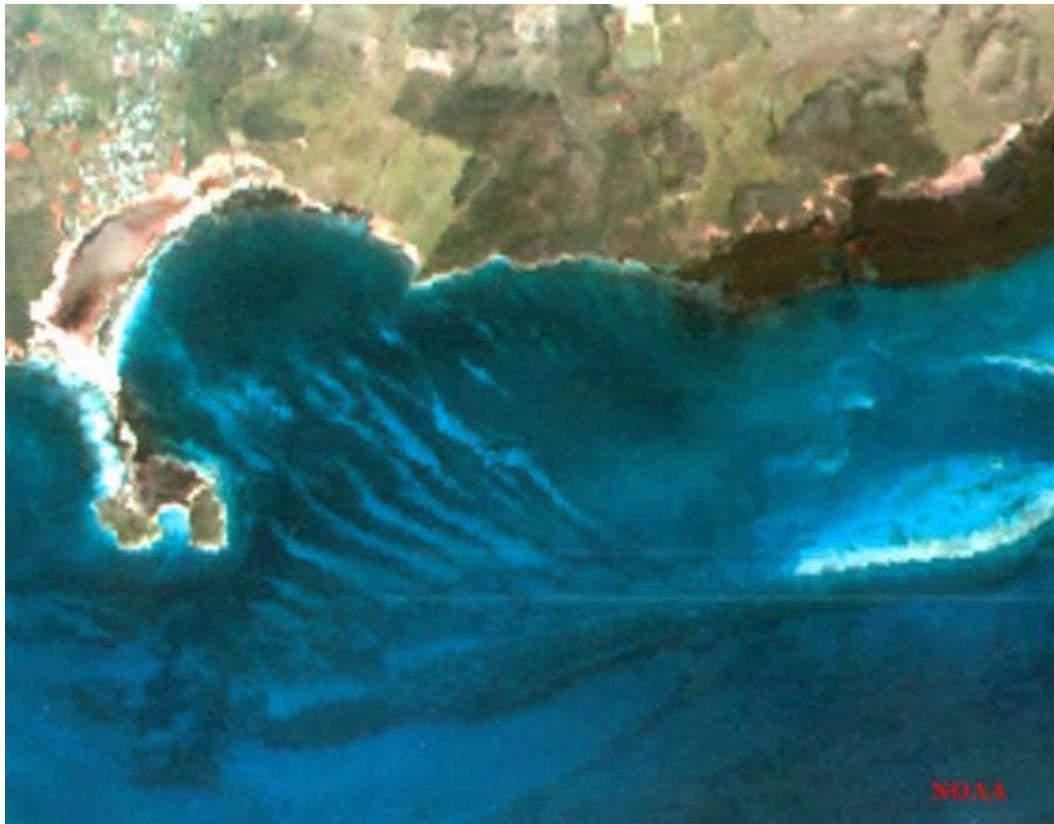
Figure 48. Sand waves outside Bahía Sucio. The sand continues south and west of Pta. Cabo Rojo

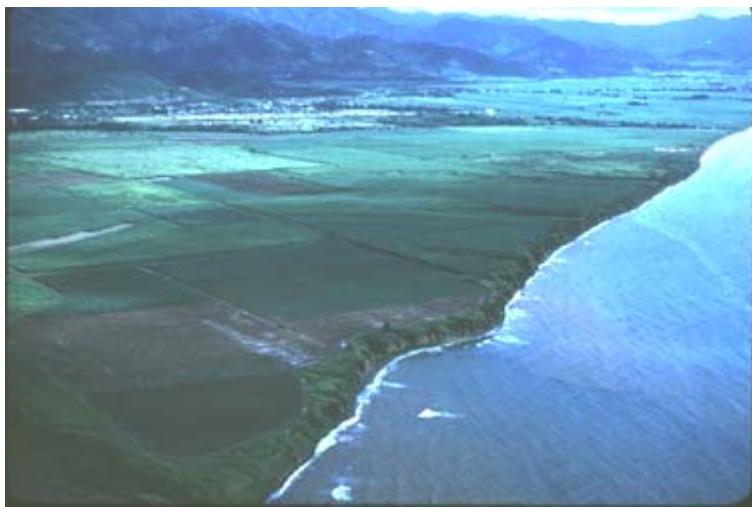
Figure 53. Arroyo cliffs with narrow beach at base of cliffs

The coastline from Jauca to Playa Salinas is a combination of beach plain and mangrove. East of Salinas there is considerable mangrove coast. The Cayos Caribe are small mangrove islands that are behind a fringing reef coastline. From Las Mareas eastward the coast is dominantly the result of wave erosion of the relatively unconsolidated alluvial plain material that lies south of the central mountains. There is extensive development of narrow beaches at the base of wave cut cliffs (Figure 53). From Arroyo eastward, the coastline is dominantly beach plain.

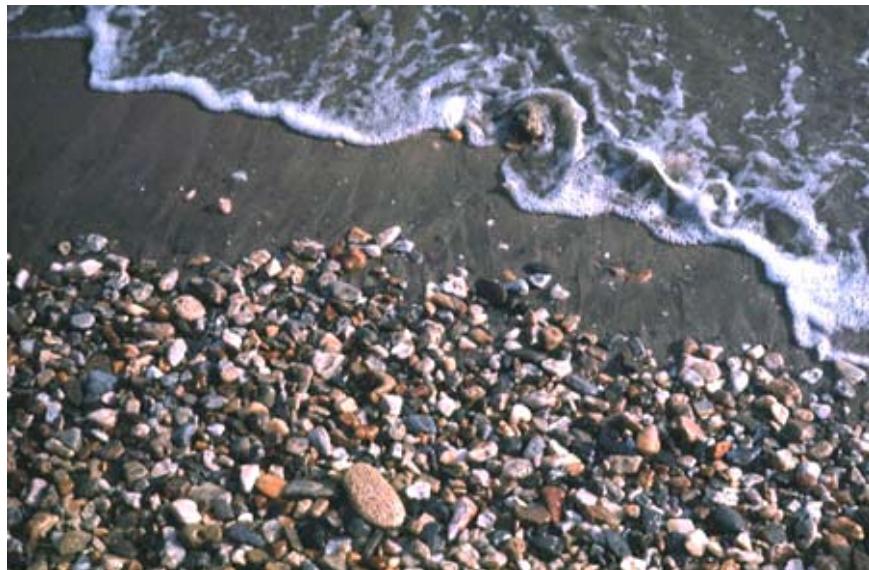
Figure 54. Beach gravel, lag material.

Much of the beach material in this part of the Island is gravel-sized (Figure 54). The gravel appears to be residual alluvial plain material left in the surf zone as the alluvial plain is cut back by wave action on many of the beaches.

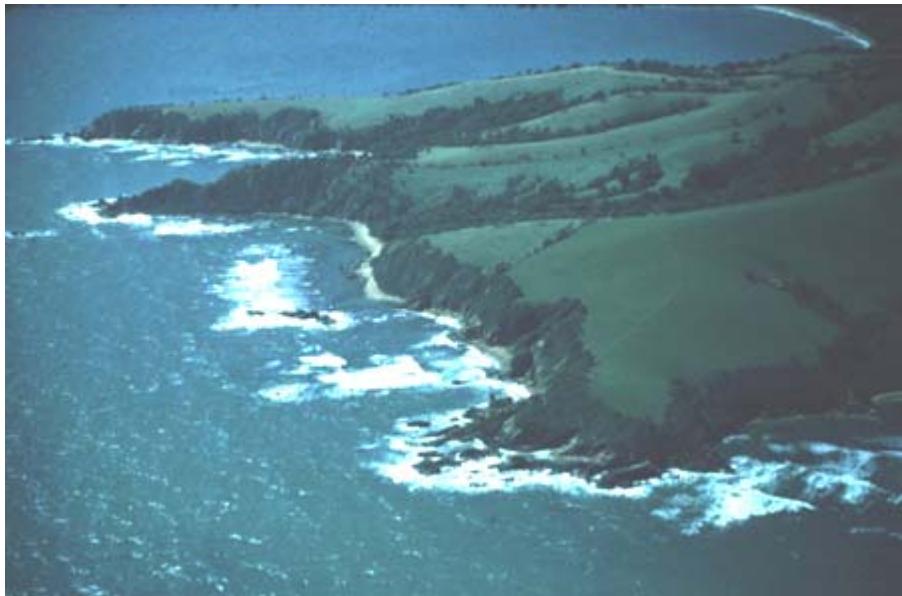
Figure 56. Pocket beaches at the southeast tip of Puerto Rico

The coastline from Punta Tuna to Naguabo is an alternation of rocky headlands that have been partly shaped by marine erosion and valleys of alluvial material that have been worked on by wave action and marine deposition to form broad beach plains. North of Punta Lima the coastline is mangrove coast, rocky headlands, and a few small beach plains and pocket beaches (Figure 56).

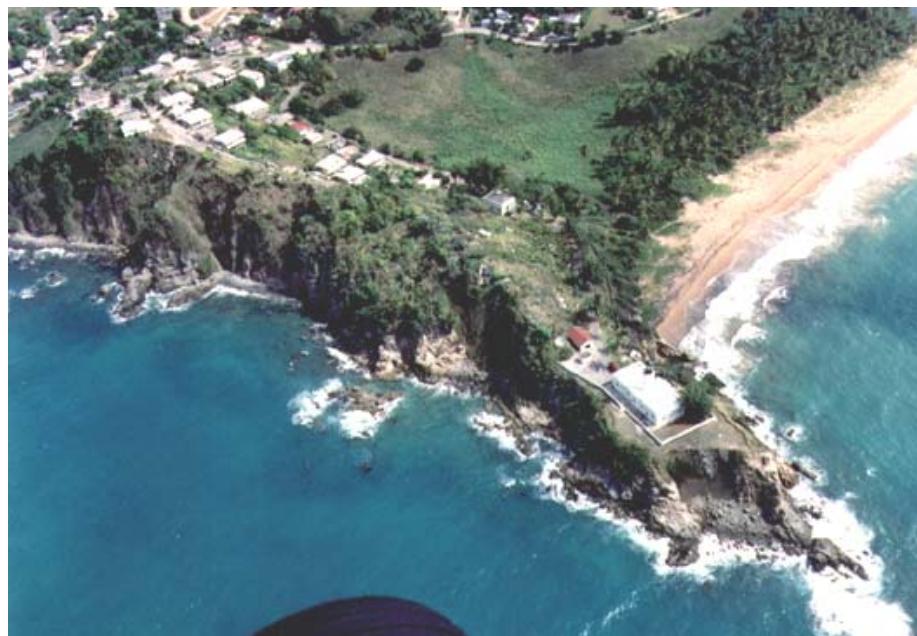
Figure 57. Punta Tuna and beach

Punta Tuna beach is a beautiful coarse carbonate sand beach with some quartz and igneous rock material that lies east of the Punta Tuna lighthouse (Figure 57). The land adjacent to the beach is pasture for large herds of cattle, but the owners have provided access to the beach.

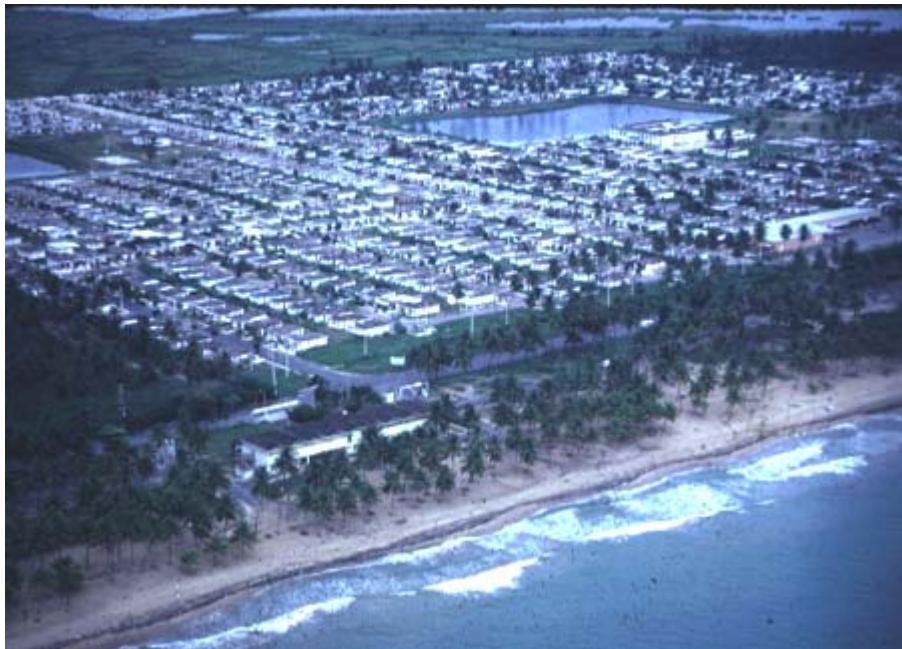
Figure 58. Humacao beach

The Candelero beach system starts with a group of small pocket beaches between Punta Guayanes and Punta Fraile. There is a continuous beach plain from the Palmas del Mar marina at Punta Fraile to Morro de Humacao (Figure 58). The composition is dominantly calcium carbonate. There is erosion at Punta Candelero and for a short distance north.
