# SHORELINE OF PUERTO RICO

**COASTAL ZONE PROGRAM  
DEPARTMENT OF NATURAL RESOURCES  
PUERTO RICO**

SHORELINE OF PUERTO RICO

JANUARY 1978

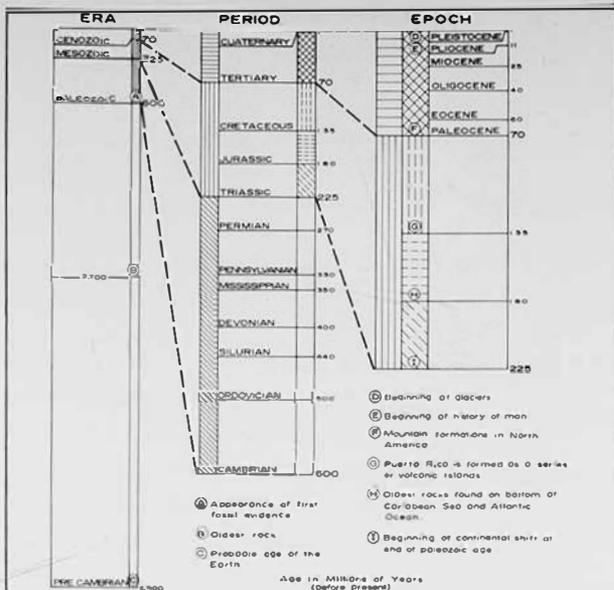
Fig. 1 geological time scale  
The absolute age of the earth and history of past events is measured by the decay of radioactive elements. The ratio between decay products and parent radioactive materials is used to determine the elapsed time since the rock was formed. Sequences of change used include:  
uranium 238 to lead 206  
thorium 230 to lead 208  
potassium 40 to argon 40  
carbon 14 to nitrogen 14

The geological history of the earth is read from clues left in the rock record (fig. 1). The fossilized remains of past life in sedimentary rocks and radioactive dates from igneous rocks allow us to derive a calendar of earth history. Geological evidence indicates that the earth was formed more than 4.5 billion years ago. In rocks of Cambrian age, formed more than 600 million years ago, we find preserved fossil remains of plant and animal life. These fossils and geophysical evidence indicate that in the past the arrangement of oceans and continents was greatly different from the present distribution.

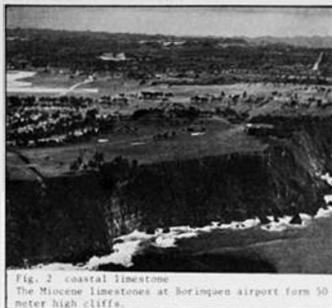
Fig. 2 coastal limestone  
The Miocene limestones at Borinquen airport form 50 meter high cliffs.

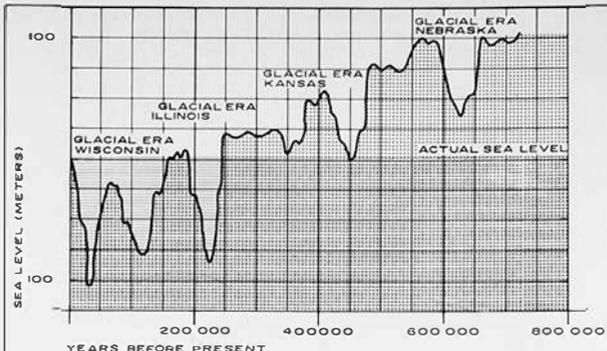
Fig. 5 glacial fluctuations of sea level. As the glaciers grew and advanced over land areas, the precipitation being added to the ice mass was supplied by removal of seawater from the oceans. This resulted in a loss of volume of available seawater and subsequent lowering of sea level in relation to the land. Each glacial episode is named for the maximum geographic advance of the ice sheets over North America.

Four major glaciations occurred during Pleistocene time (fig. 5). Each of these glaciations caused a lowering of sea level of about 100 meters. The interglacial periods witnessed a retreat of ice and a rise of sea level. There has been an overall lowering of sea level since the beginning of Pleistocene time as water has been permanently trapped in the higher latitudes. The final glaciation, the Wisconsin, had the most profound effect on the present coastal features, and the rising sea level following glacial retreat is one of the major factors affecting our present coastal pattern and beaches.

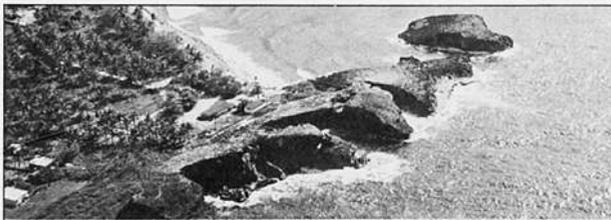
Fig. 6 eolianite (fossil sand dune). These cemented sand dunes of the north coast were formed at an earlier time as dunes and were subsequently cemented.

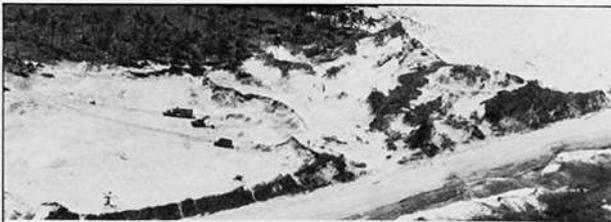
Fig. 7 Coastal sand dunes. The sand dunes north and east of Borinquen airport form a reservoir of sand for beach nourishment. They have been exploited for commercial sand and offer little protection to the shore against hurricane associated waves.

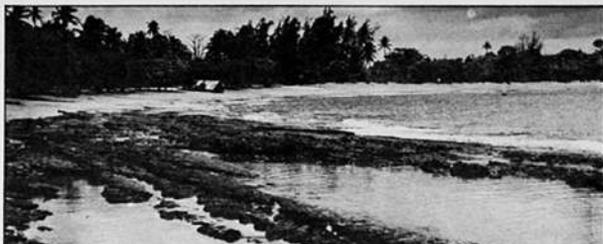
Fig. 8 beachrock

The cemented sands at Ciboco, on the north coast, mark former shoreline positions. Many of the north coast beachrock exposures are less than 100 years ago and were cemented while underlying the beach system. Their exposure indicates conditions of erosion.

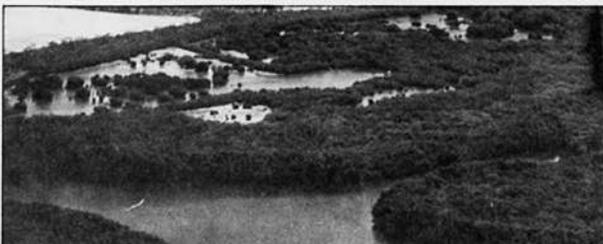
Fig. 9 mangrove swamps

La Parguera forest on the south coast is one of the major mangrove coasts. The growth of the mangrove and trapping of sediments has resulted in accretion of land area to the island.

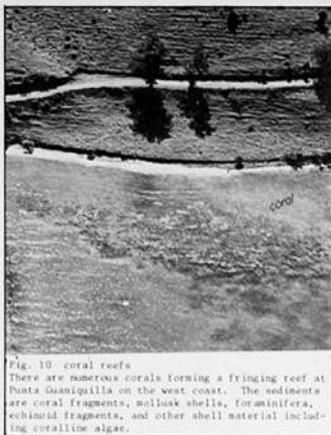
Fig. 10 coral reefs

There are numerous corals forming a fringing reef at Punta Guaniquilla on the west coast. The sediments are coral fragments, mollusk shells, foraminifera, echinoid fragments, and other shell material including coralline algae.

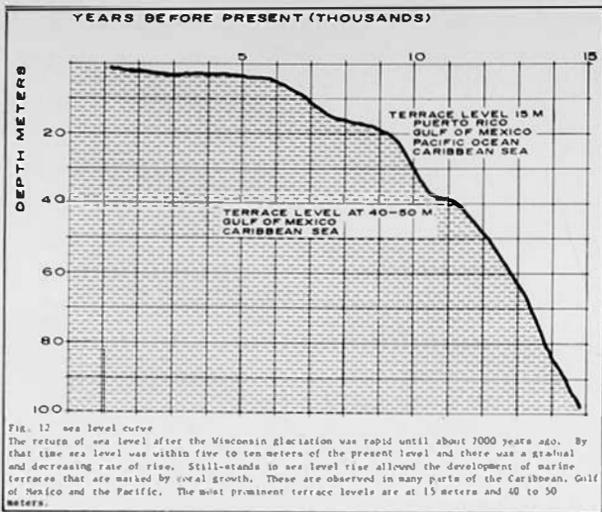
FIG. 12 sea level curve

The return of sea level after the Wisconsin glaciation was rapid until about 10,000 years ago. By that time sea level was within five to ten meters of the present level and there was a gradual and decreasing rate of rise. Still-stands in sea level rise allowed the development of marine terraces that are marked by coral growth. These are observed in many parts of the Caribbean, Gulf of Mexico and the Pacific. The most prominent terrace levels are at 15 meters and 40 to 50 meters.

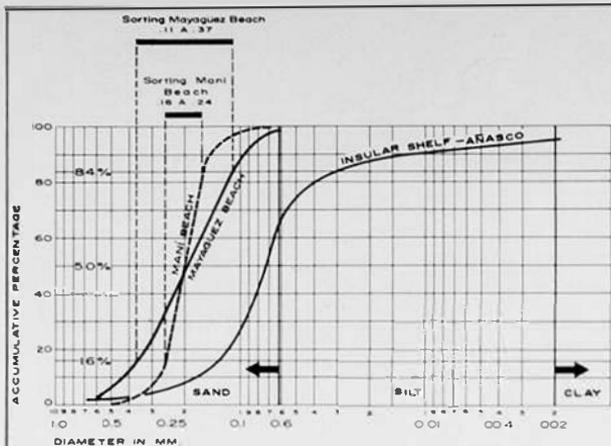
Fig. 31 Grain size distribution plots. Beach sands plot as a normal probability curve on semilog paper. The vertical axis is cumulative percent of the total and the horizontal axis is grain size in millimeters diameter. The two samples are 98 to 100 percent sand size material. The spread of sizes at range between the 16th and 84th percentiles is a measure of sample sorting. The Mani sample has much better sorting than the Mayaguez beach sample. The siltline is a function of source materials and wave energies.

The sample from offshore of Mani Beach is a sand and silt mixture with a small amount of clay.  
 sand 57% silt 33% clay 1%

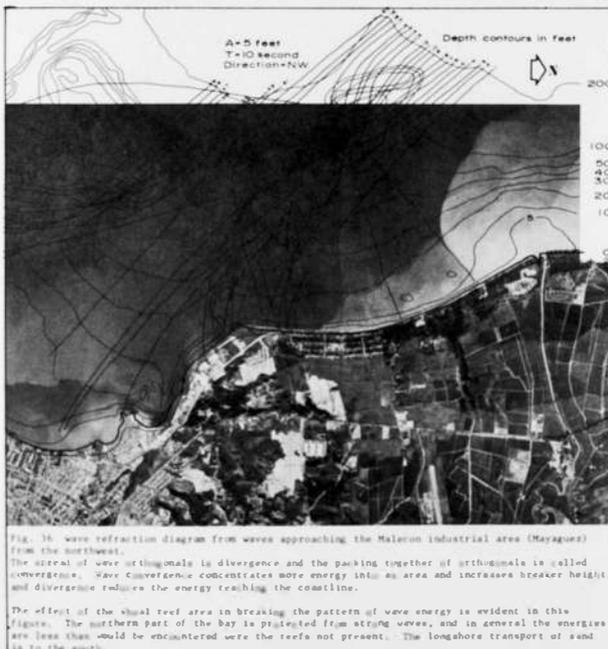
Fig. 36 wave refraction diagram from waves approaching the Malabar Industrial area (Mayaguez) from the northwest. The arrival of wave orthogonals is divergence and the piling together of orthogonals is called convergence. Wave convergence concentrates more energy into an area and increases breaker height, and divergence reduces the energy reaching the coastline.

The effect of the shoal reef area in breaking the pattern of wave energy is evident in this figure. The northern part of the bay is protected from strong waves, and in general the energies are less than would be encountered were the reefs not present. The longshore transport of sand is to the south.

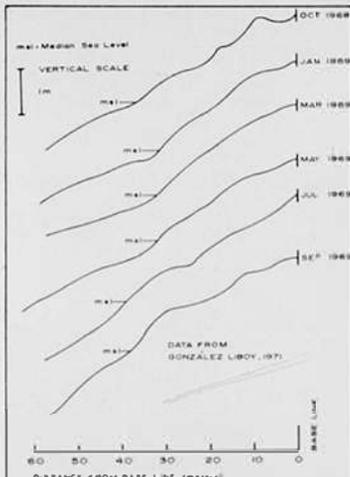
Fig. 39 beach profiles from Miami Beach for 1968-1969  
These show the seasonal migration of beach sand onshore and offshore.

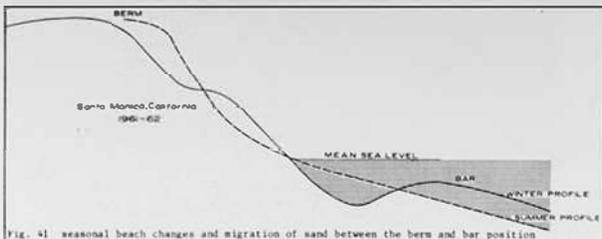
Fig. 41 seasonal beach changes and migration of sand between the berm and bar position

After the stormy season, wave steepness decreases and sand is moved shoreward (fig. 41). The material from the bar migrates to the berm, building it seaward. Except on very flat beaches, the berm usually has a well defined edge, the crest, and the method of growth can be observed by watching the action at the crest. As each wave reaches the beach face, its remaining energy is spent in a thin swash of water carrying sand upward. Part of the water sinks into the beach and does not return as backwash. Thus the energy in the returning water is less, and sand is added to the berm at the crest.

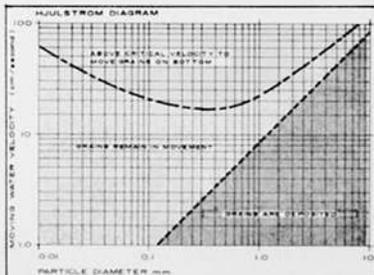
Fig. 42 Mulmström diagram  
The critical velocities at which a grain of a particular size will be eroded from the bottom, deposited on the bottom, or transported if in suspension are given by this plot of grain diameter (in millimeters) versus current velocity (in centimeters per second). The diagram was constructed from experimental data and illustrates that once grains come to rest on the bottom, higher current velocities are required to move them than while they are in suspension.

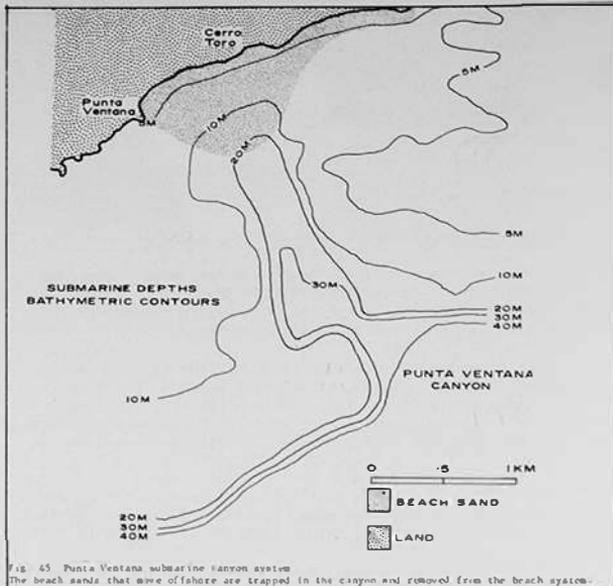
Fig. 45. Punta Ventana submarine canyon system. The beach sands that move offshore are trapped in the canyon and removed from the beach system.

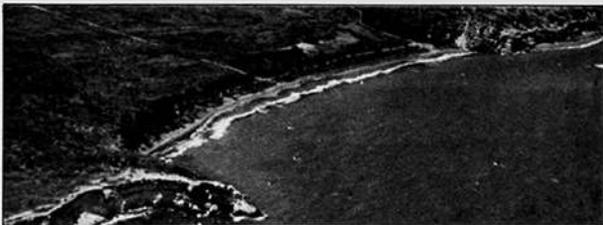
Fig. 58 Puerto Rico beach system example: Punta Ventana. This beach is bounded east and west by rock outcrops of limestone. The sands are a mixture of carbonate grains and dark igneous rock fragments and minerals. Reefs to the east supply carbonate shell material and the terrigenous component is from the old river valley of the Yauco River. (East is to the right; longshore transport is westward; Punta Ventana on left, Cerro Toro on right).

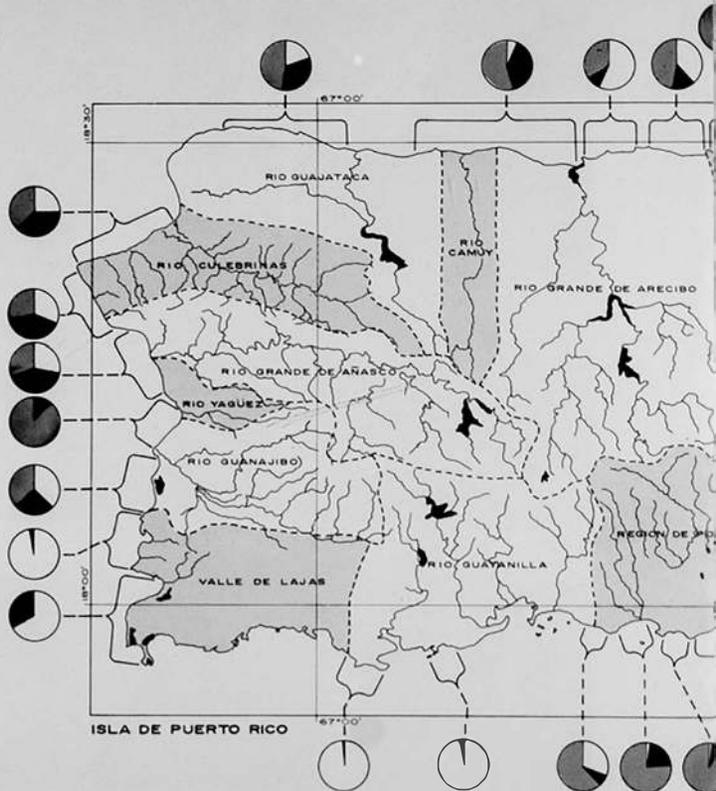
Fig. 64

The distribution of these types of coast are shown on fig. 64.

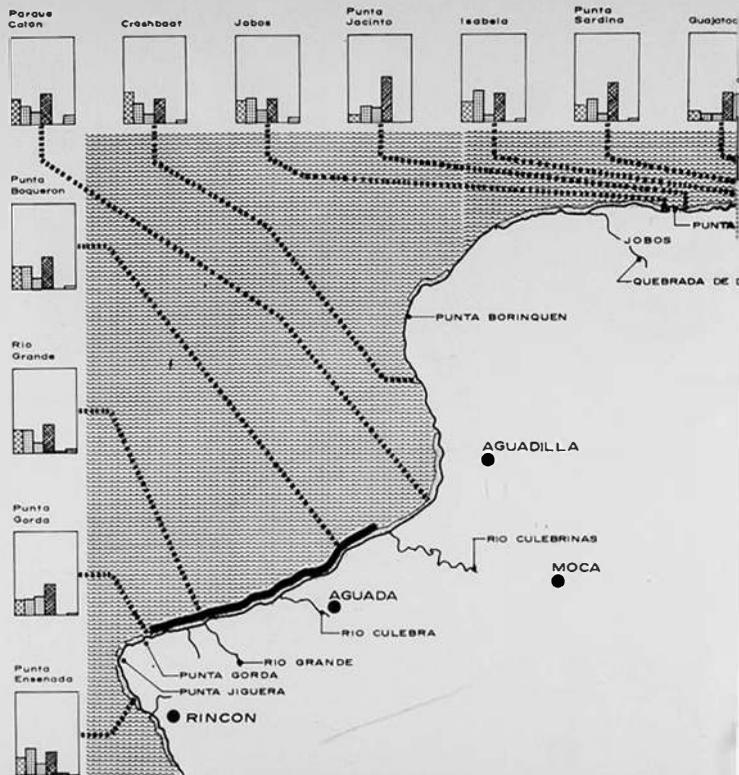
Fig. 107. Along much of this coast, the sands are a very thin veneer over a rocky shoreline. They are mixed mainly by storm waves.

Punta Borinquen and Crashboat beaches are isolated beaches bounded by rocky shoreline (fig. 106). The beach is continuous from Aguadilla to Punta Gorda, and the coastal type is beach plain (fig. 107).

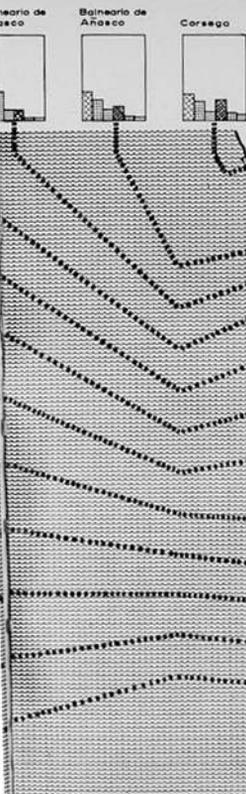
Plate 5

different from the Añasco beach system. The deep water of the Mayaguez Harbor entrance blocks transport of sand from the Añasco system to Mayaguez beach.

There is severe erosion along the southern half of Mayaguez beach. Riprap has been added to long stretches for protection until the coastline is no longer beach (fig. 111). This has slowed the loss, but has also shifted the erosion to another part of the beach until riprap now extends to the Guanajibo River. The September 1975 flood made major alterations to the beach (fig. 112) and ripped out both highway and riprap (fig. 113). Prior to the flooding, the severity of the beach erosion was shown by the undermining of homes on the beach (fig. 114). The flood carried large amounts of sand offshore. Some of these sands may return to the beach system, but most will be covered by the marine silts that are the dominant sediment beyond the three meter depth contour.

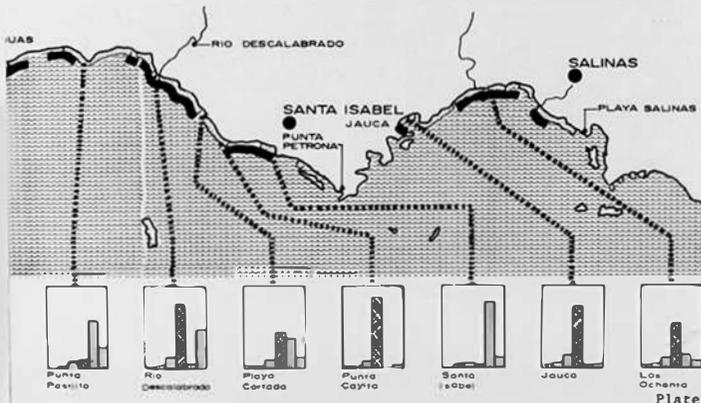
Plate 7

The beach at Punta Cuchara is being rapidly eroded and a large amount of the land behind the beach has been removed. The low beach to the east, Playa de Ponce, is a free sand removal area and a garbage and junk dump site. It is one of the worst looking stretches of coastline in Puerto Rico (fig. 124). From Punta Carenero east to Punta Petrona, there is almost continuous beach plain interrupted by mangrove, eroding alluvial plain, and rock riprap (fig. 125). More than fifty percent of this coast is suffering severe erosion. The materials range from sand to gravel and are dominantly dark minerals and rock fragments. Several of the beaches have especially high concentrations of magnetite.

The coastline from Jauca to Playa Salinas is a combination of beach plain and mangrove. East of Salinas there is considerable mangrove coast. The Cayos Caribe are small mangrove islands that are behind a fringing reef coastline. From Las Mareas eastward the coast is do-

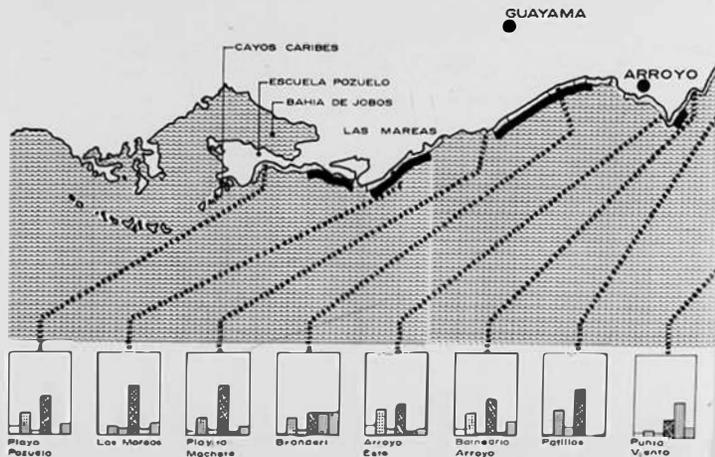
Fig. 128. Jobsos. Rapid erosion of the shoreline has resulted in a maze of palm trees lying in the water. An extremely large area of former mangrove has been killed.
